City of Boulder City Historic Water Filtration Plant  
Historic Structures Final Report

February 23, 2022

# Pre-Demolition Asbestos and Lead Based Paint Survey Boulder City Historic Water Filtration Plant 300 Railroad Avenue Boulder City, Nevada

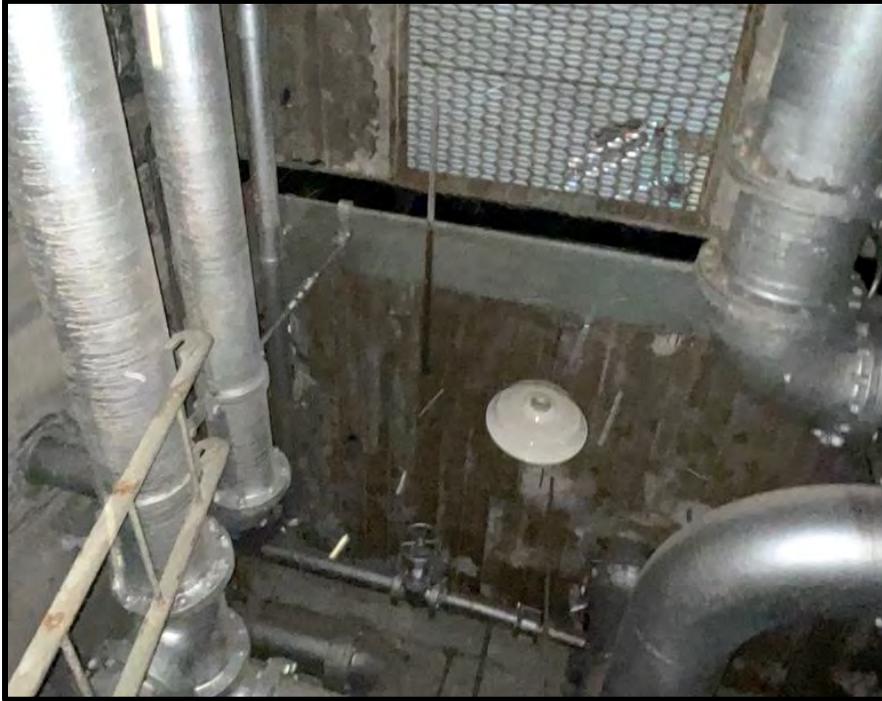
Figure 23 – View of Spalling at Underside of Operating Floor Concrete Slab

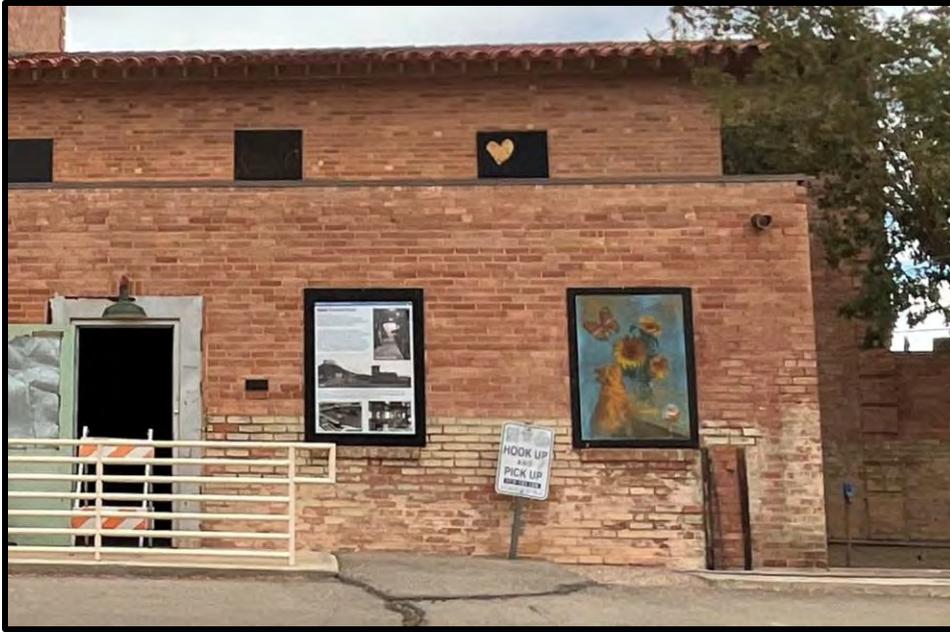
Figure 29 – Mortar Loss Due to Rising Damp

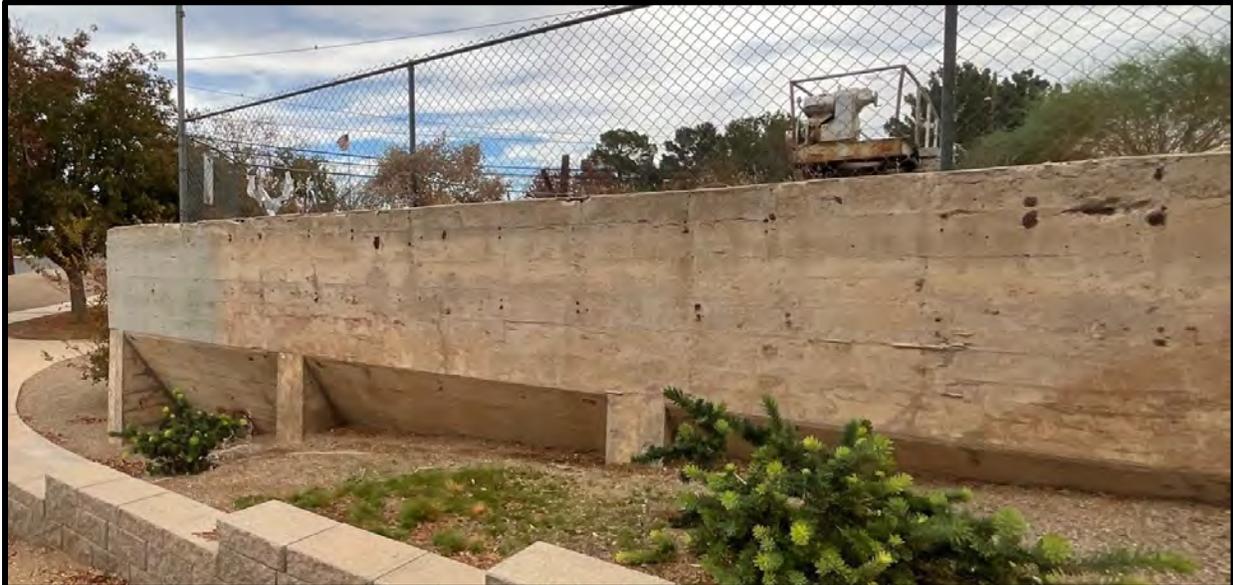
Figure 30 – Concrete Damage at Top of Walls

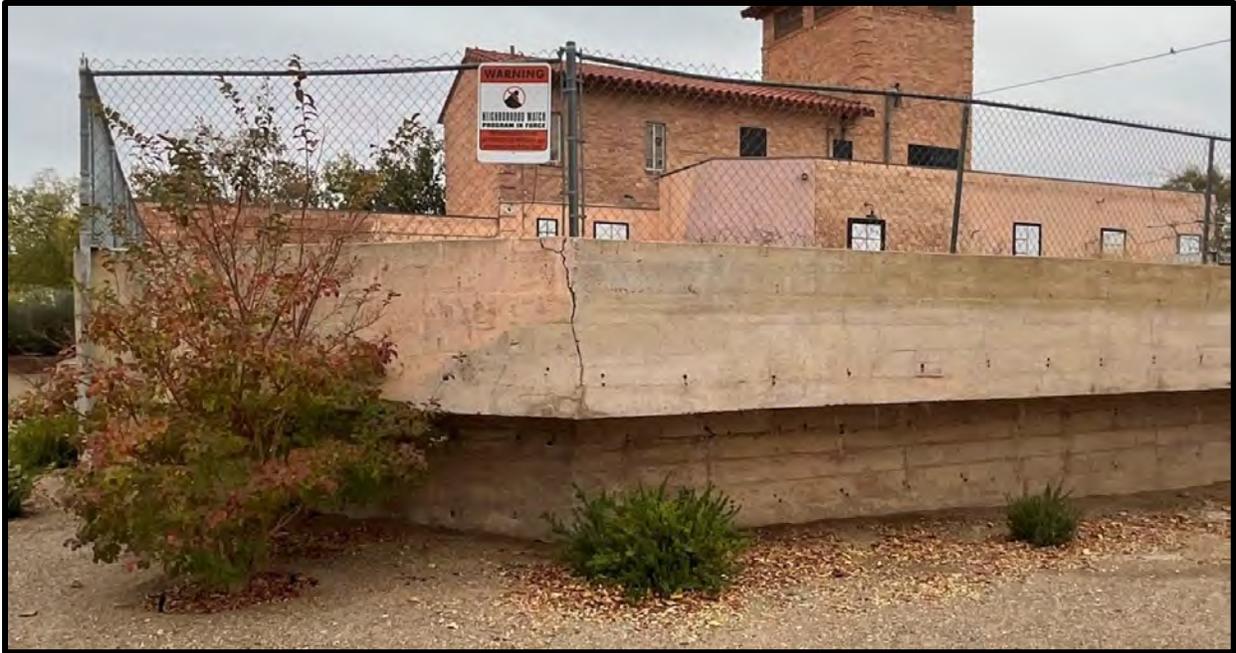
Figure 31 – Crack at Clarifier Tank Retaining Wall

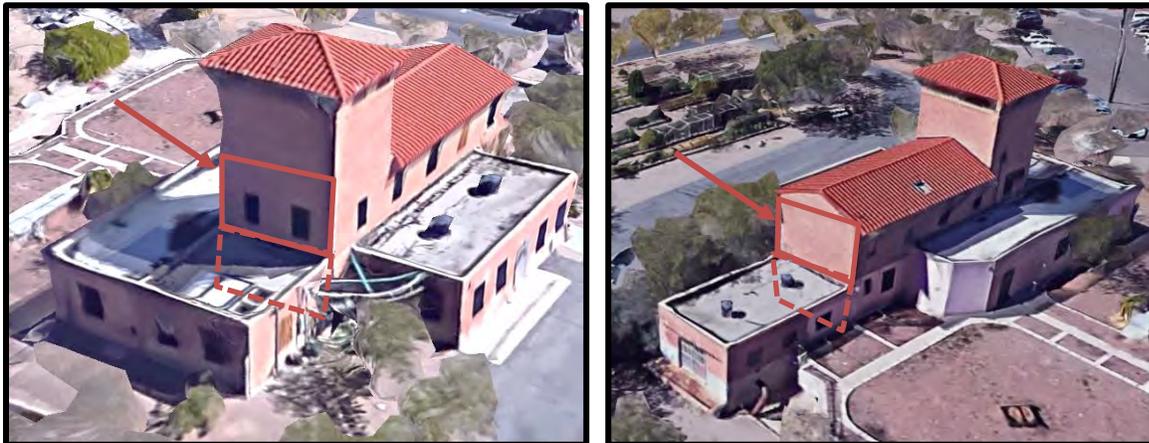
Figure 35 –Vulnerable wall piers in the Northwest Elevation (left) and Southwest Elevation (right)
