THE SECRETARY
OF THE INTERIOR'S
STANDARDS FOR
THE TREATMENT
OF HISTORIC
PROPERTIES

WITH
**GUIDELINES FOR
PRESERVING,
REHABILITATING,
RESTORING &
RECONSTRUCTING
HISTORIC
BUILDINGS**

U.S. Department of the Interior
National Park Service
Technical Preservation Services

STANDARDS FOR REHABILITATION & GUIDELINES
FOR REHABILITATING HISTORIC BUILDINGS

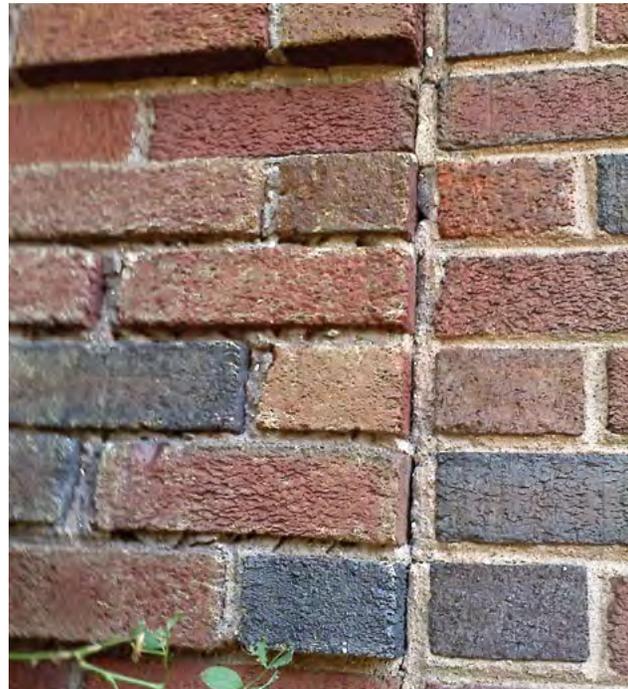
[4] Not Recommended:
The quoins on the left side of the photo show that high-pressure abrasive blasting used to remove paint can damage even early 20th-century, hard-baked, textured brick and erode the mortar, whereas the same brick on the right, which was not abrasively cleaned, is undamaged.

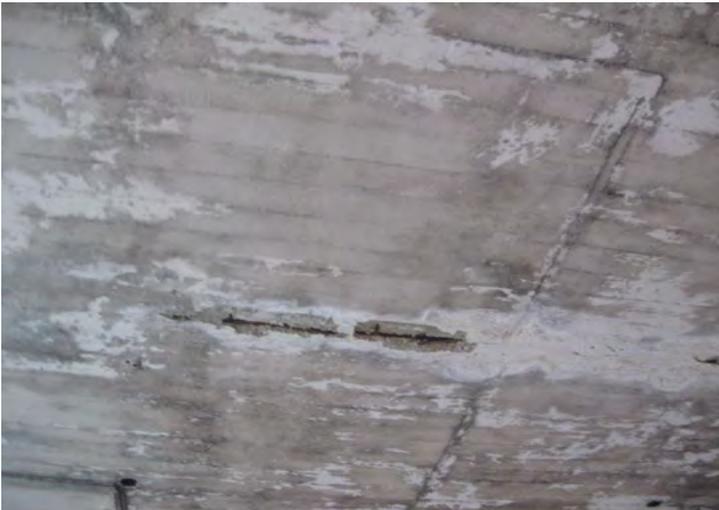
[5] Rebars in the reinforced concrete ceiling have rusted, causing the concrete to spall. The rebars must be cleaned of rust before the concrete can be patched.

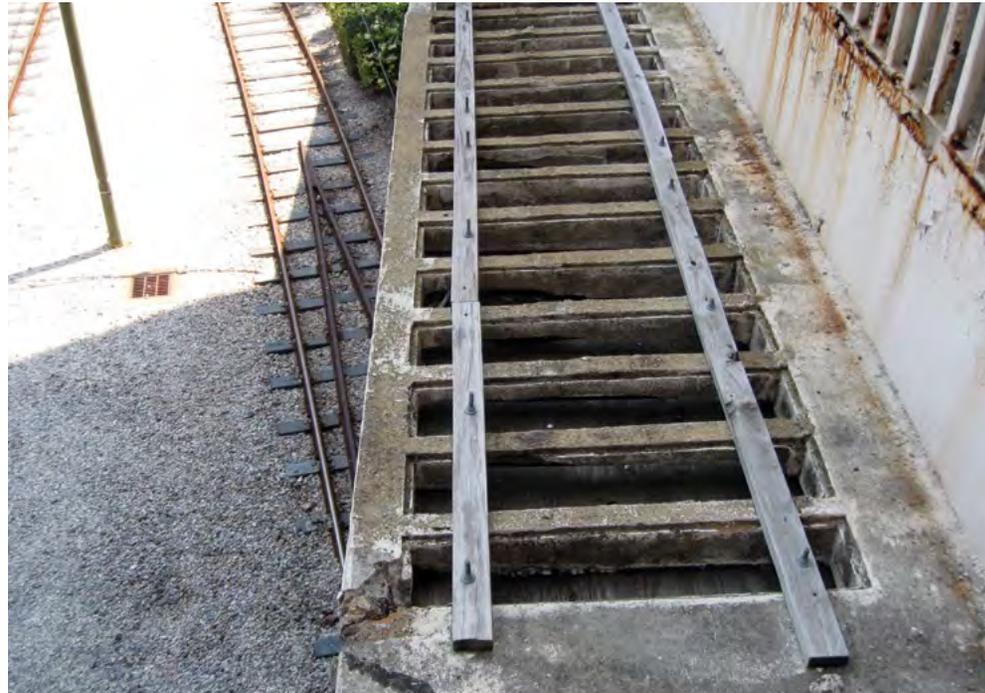
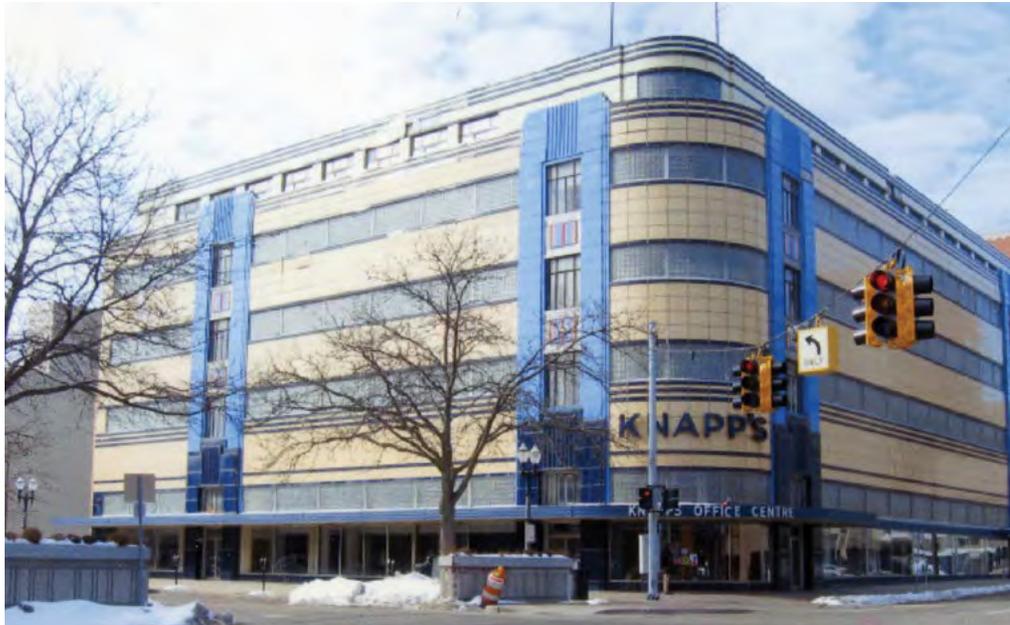
[6] Some areas of the concrete brise soleil screen on this building constructed in 1967 are badly deteriorated. If the screen cannot be repaired, it may be replaced in kind or with a composite substitute material with the same appearance as the concrete.

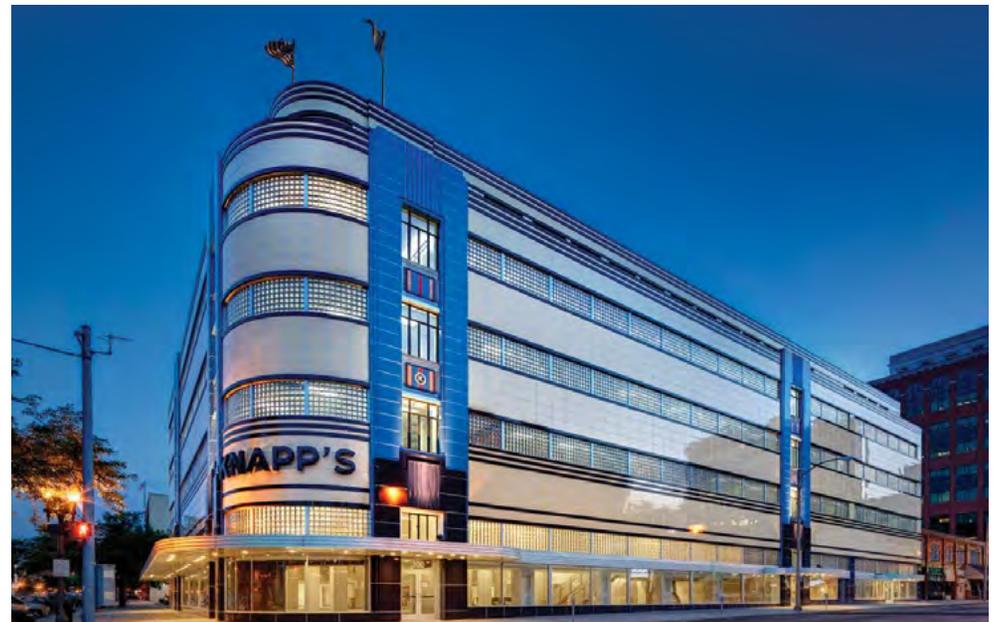
[7] (a) J.W. Knapp's Department Store, built 1937-38, in Lansing, MI, was constructed with a proprietary material named "Maul Macotta" made of enameled steel and cast-in-place concrete panels. Prior to its rehabilitation, a building inspection revealed that, due to a flaw in the original design and construction, the material was deteriorated beyond repair. The architects for the rehabilitation project devised a replacement system (b) consisting of enameled aluminum panels that matched the original colors (c). Photos and drawing (a-b): Quinn Evans Architects; Photo (c): James Haefner Photography.

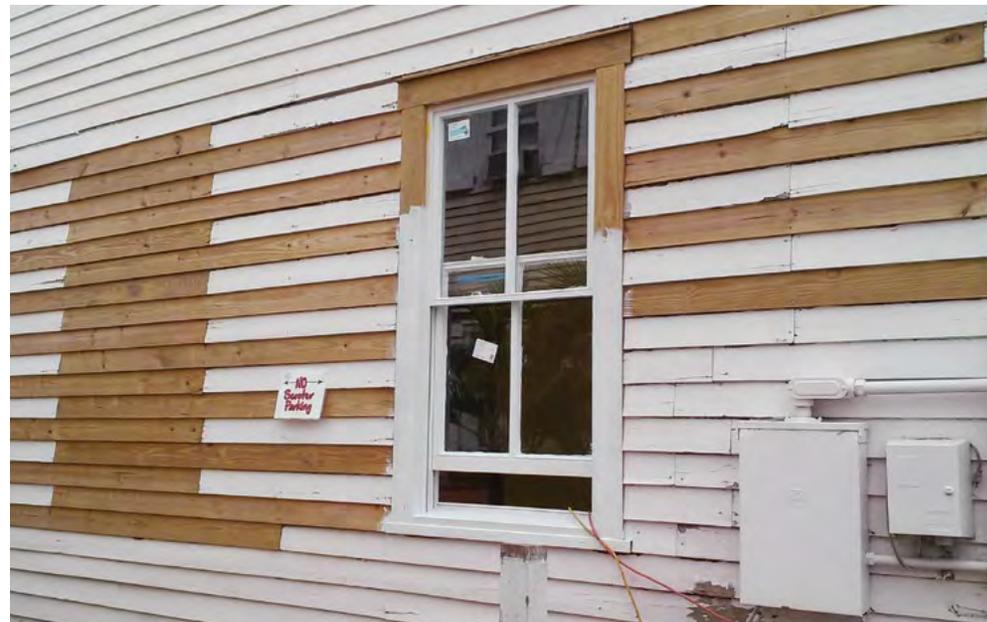
[8] Rotted clapboards have been replaced selectively with new wood siding to match the originals.

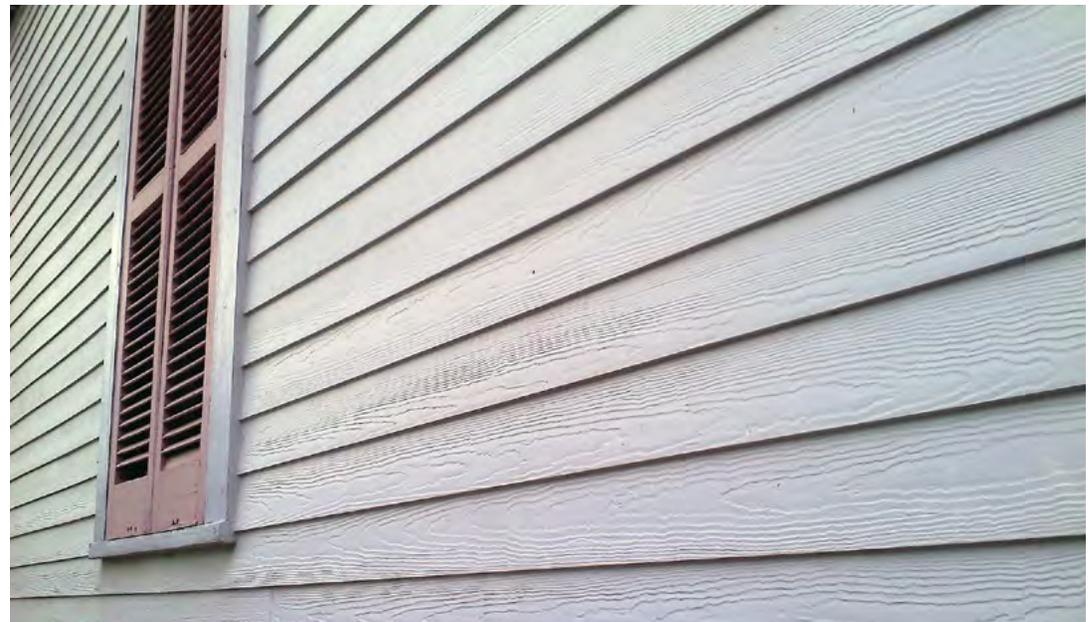
[10] **Not Recommended:** Cementitious siding with a raised wood-grain texture is not an appropriate material to replace historic wood siding, which has a smooth surface when painted.

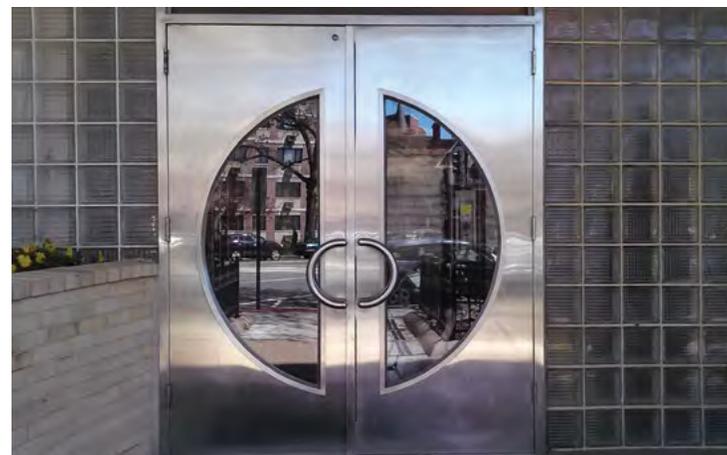
[11] The stainless steel doors at the entrance to this Art Deco apartment building are important in defining its historic character and should be retained in place.

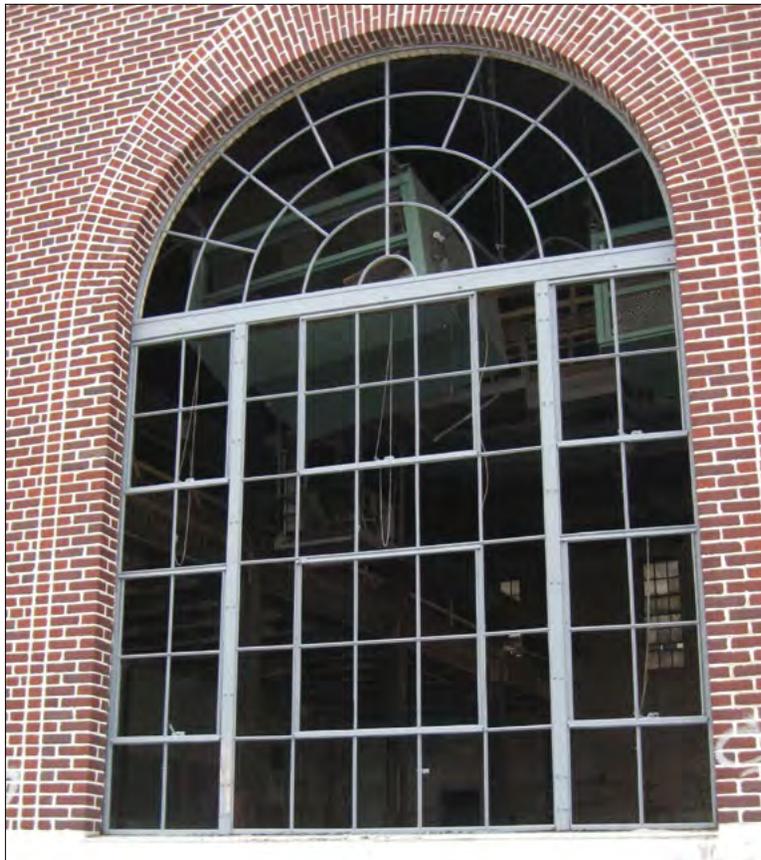
[12] This historic steel window has been cleaned, repaired, and primed in preparation for painting and reglazing.

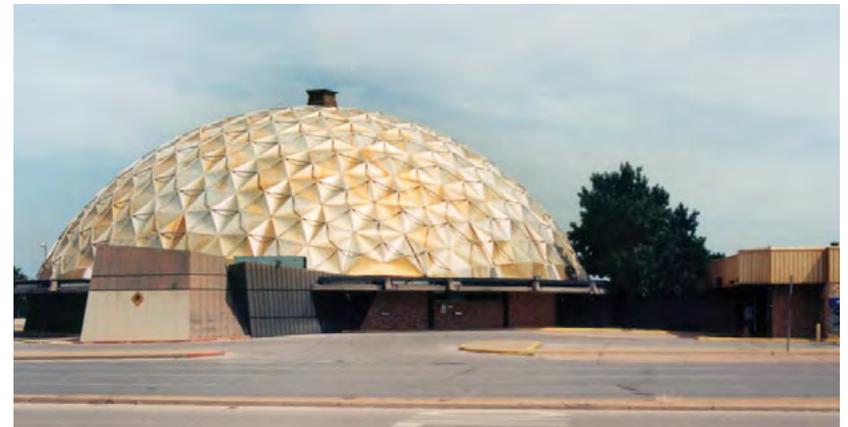
[13] The gold-colored, anodized aluminum geodesic dome of the former Citizen's State Bank in Oklahoma City, OK, built in 1958 and designed by Robert Roloff, makes this a distinctive mid-20th century building.

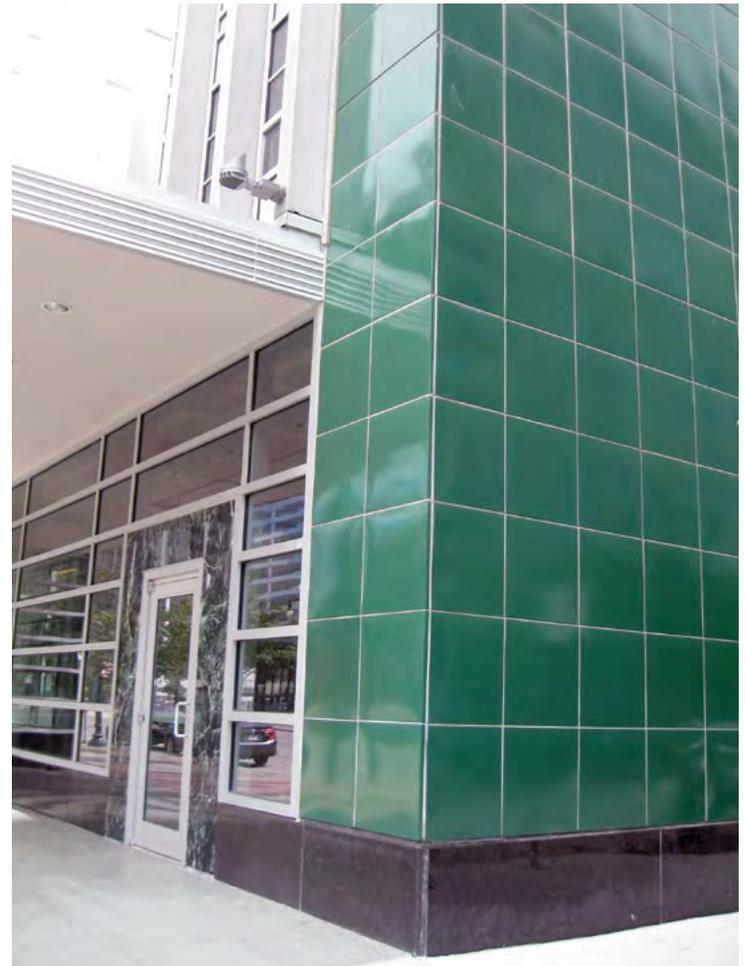
[15] New enameled-metal panels were replicated to replace the original panels, which were too deteriorated to repair, when the storefront of this early 1950s building was recreated.

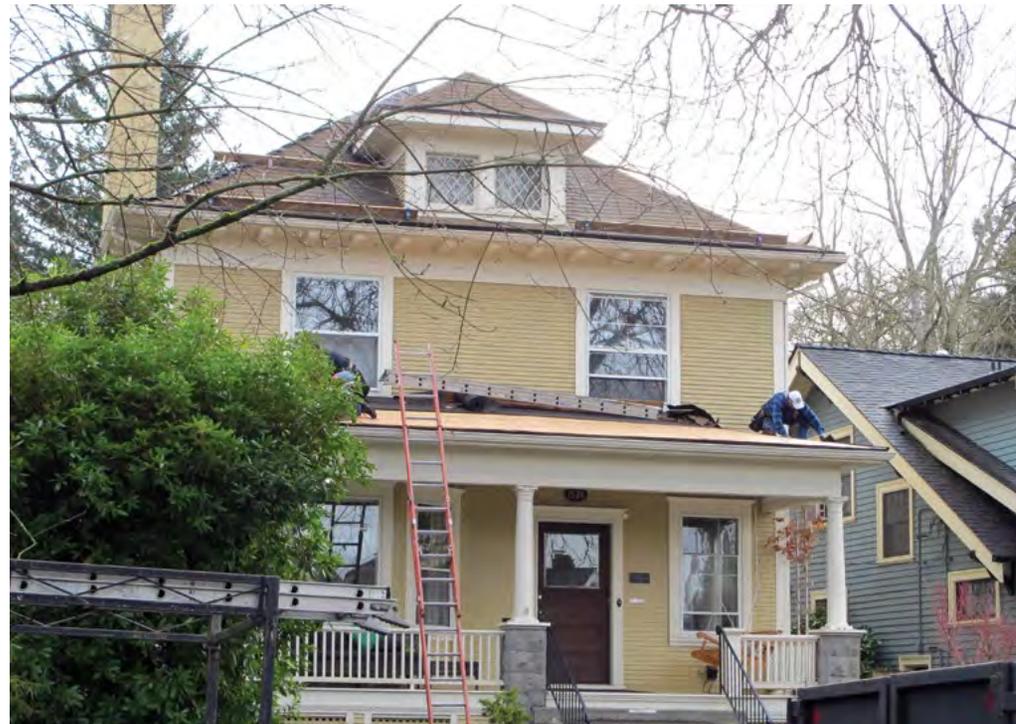
[16] The deteriorated asphalt shingles of this porch roof are being replaced in kind with matching shingles.

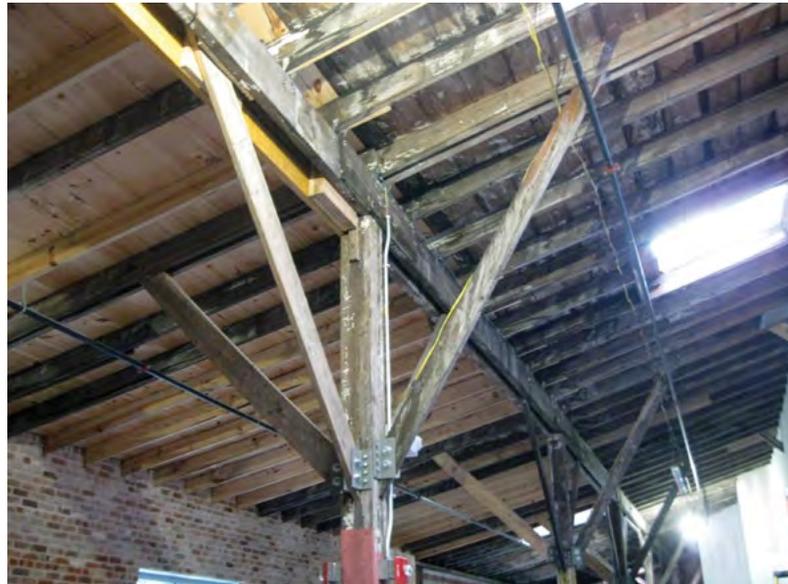
[17] New wood elements have been used selectively to replace rotted wood on the underside of the roof in this historic warehouse.

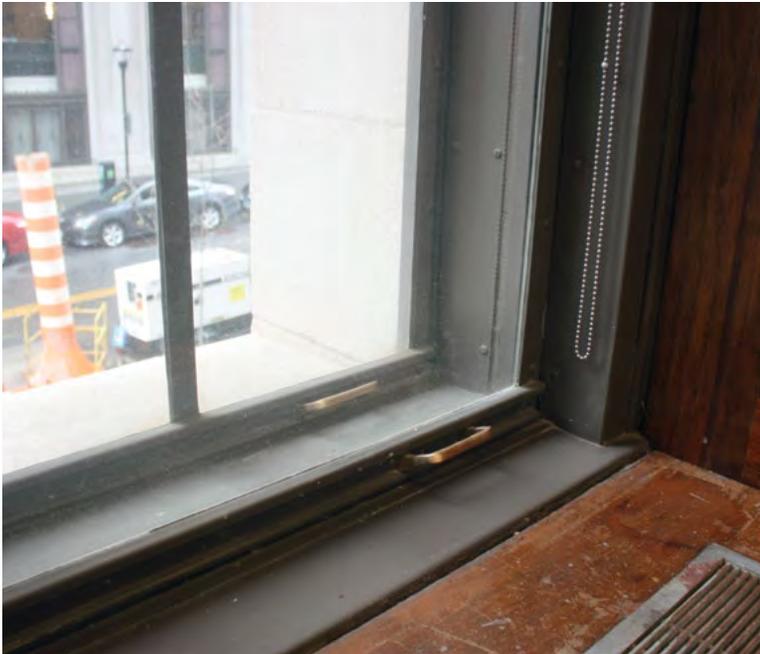
[18] The historic metal storm windows in this 1920s office building were retained and repaired during the rehabilitation project.

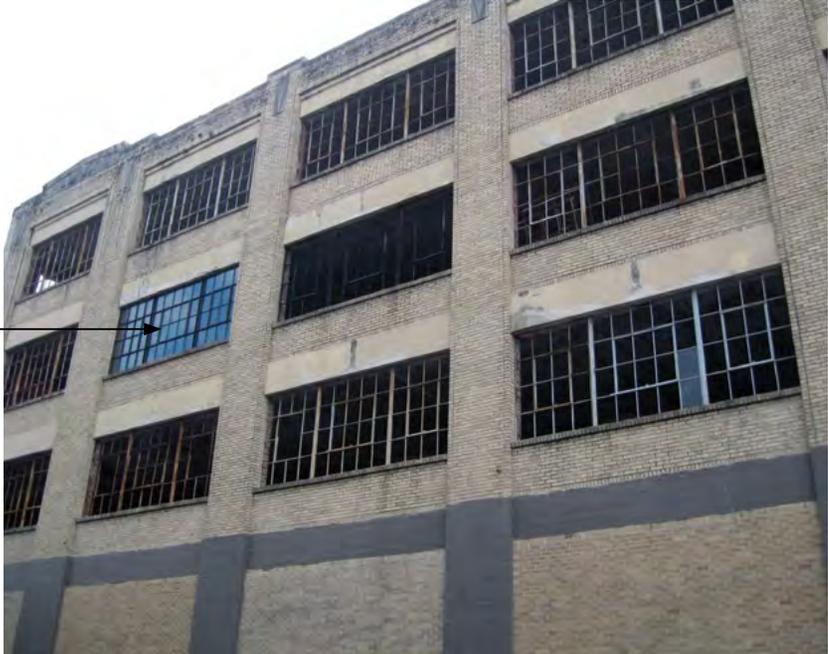
[19] Installing a mockup of a proposed replacement window can be helpful to evaluate how well the new windows will match the historic windows that are missing or too deteriorated to repair.

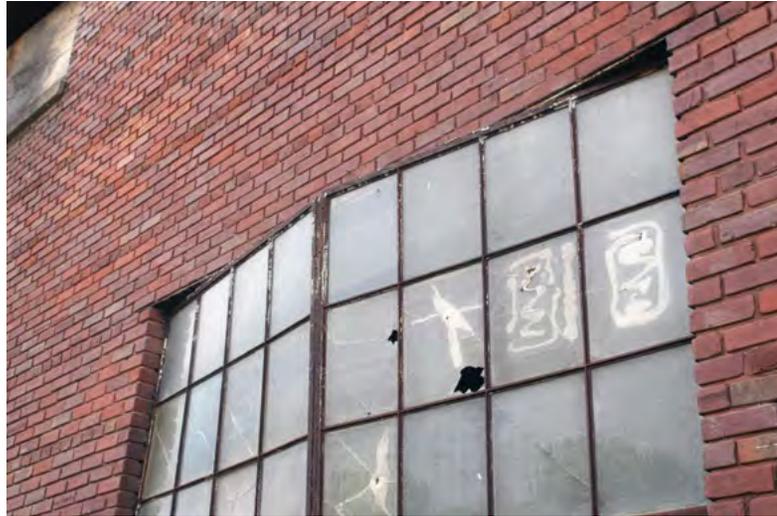
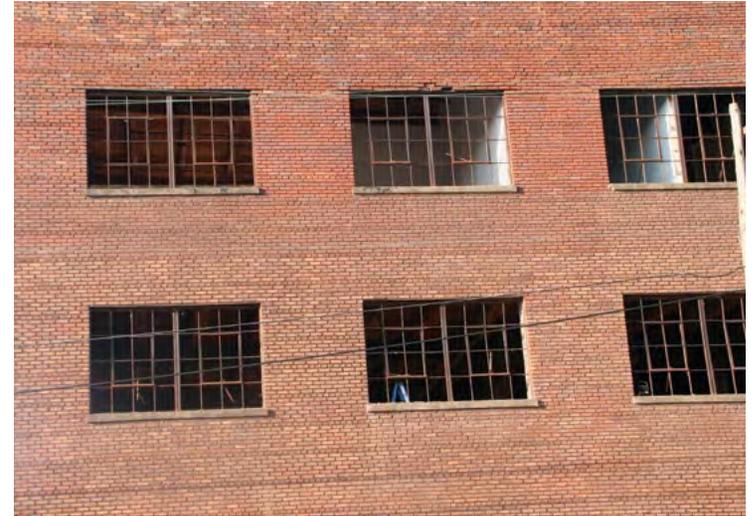
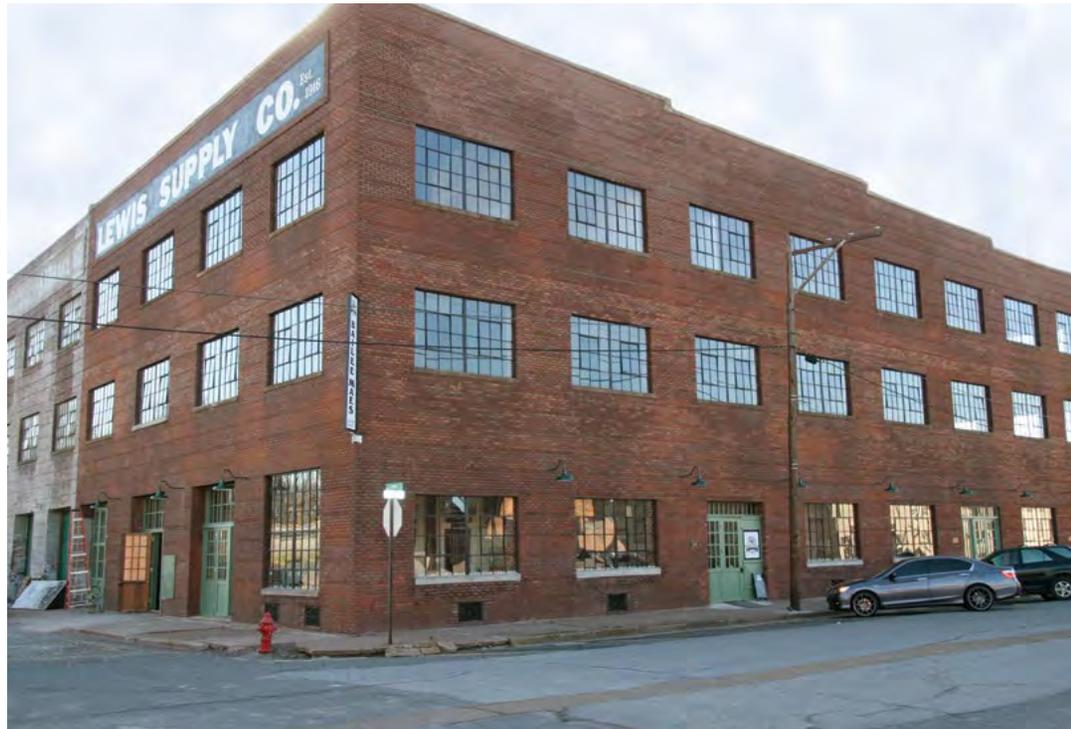
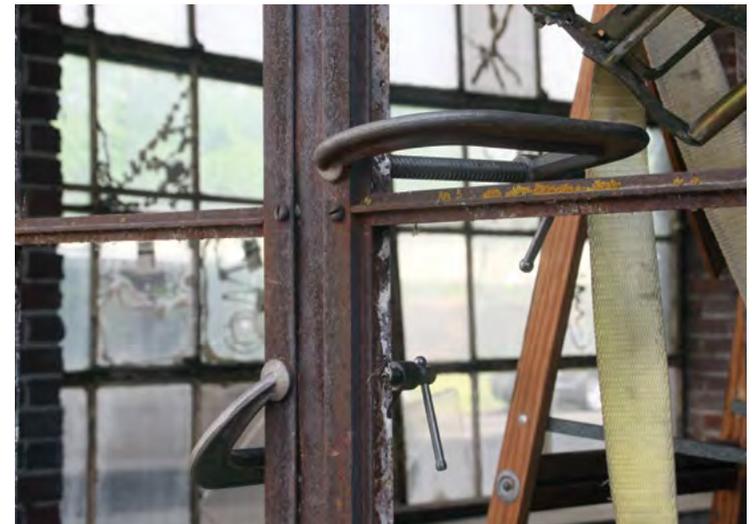
[20 a-d] The original steel windows in this industrial building were successfully repaired as part of the rehabilitation project (left).

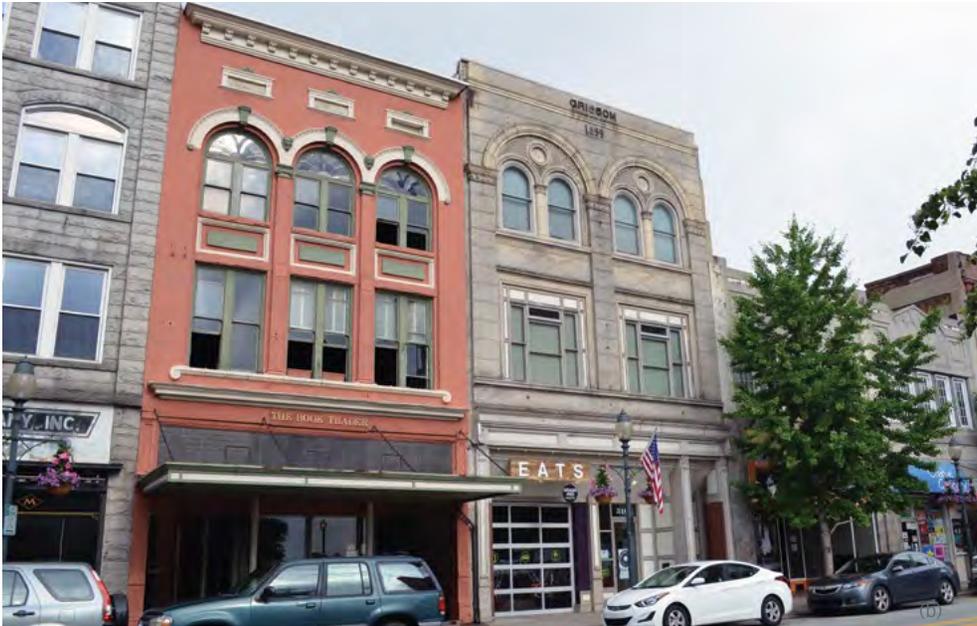
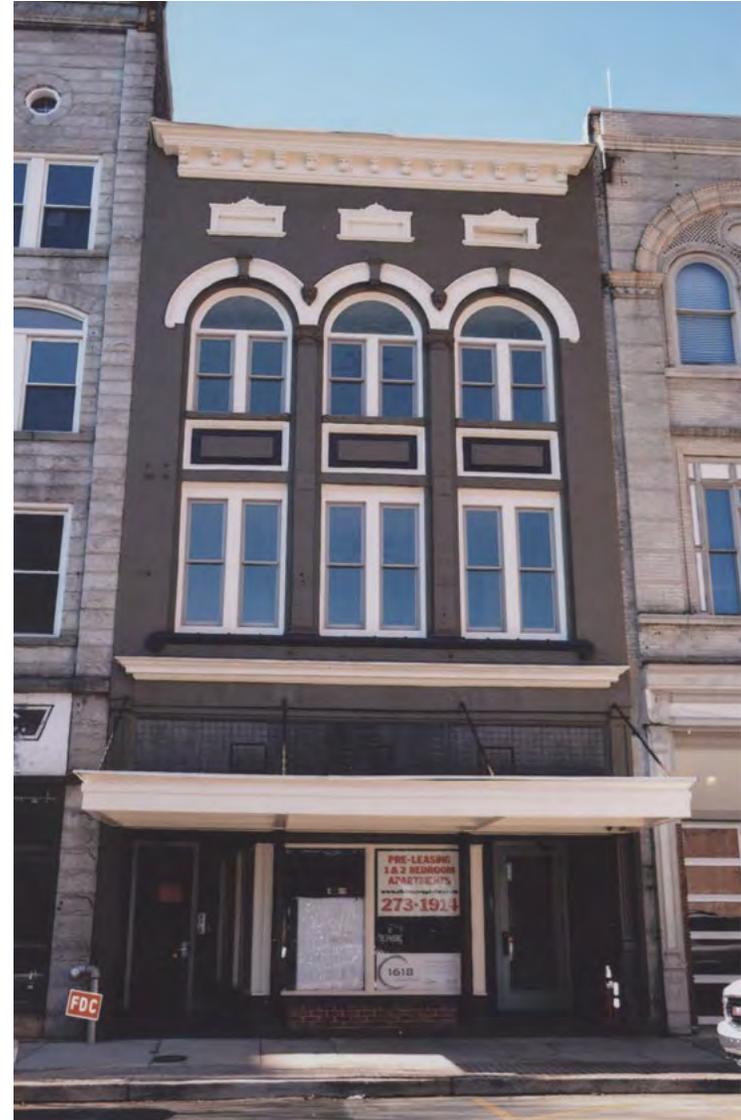
[22] **Not Recommended:** (a-b) The original wood windows in this late-19th-century building, which were highly decorative, could likely have been repaired and retained. (c) Instead, they were replaced with new windows that do not match the detailing of the historic windows and, therefore, do not meet the Standards (above).

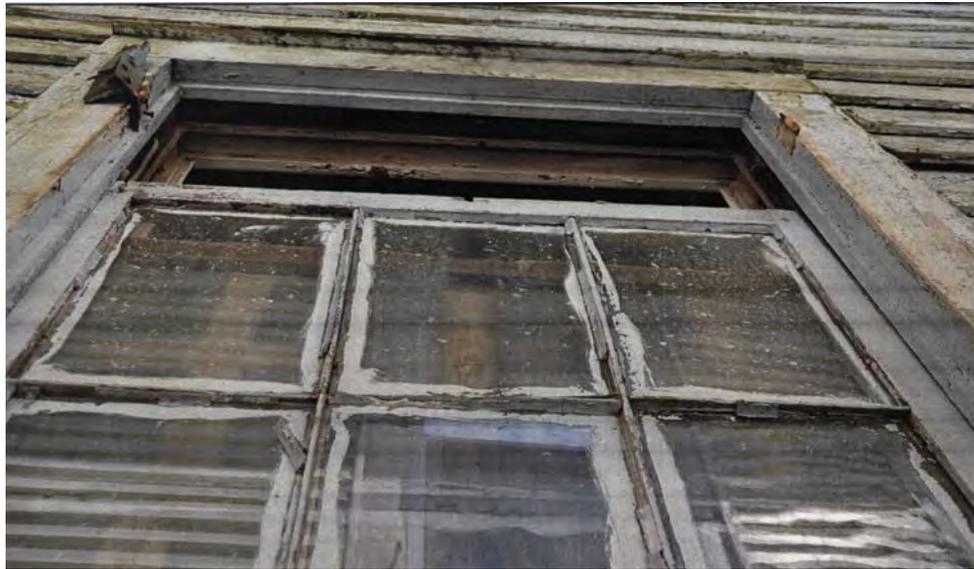
[23] (a) This deteriorated historic wood window was repaired and retained (b) in this rehabilitation project.

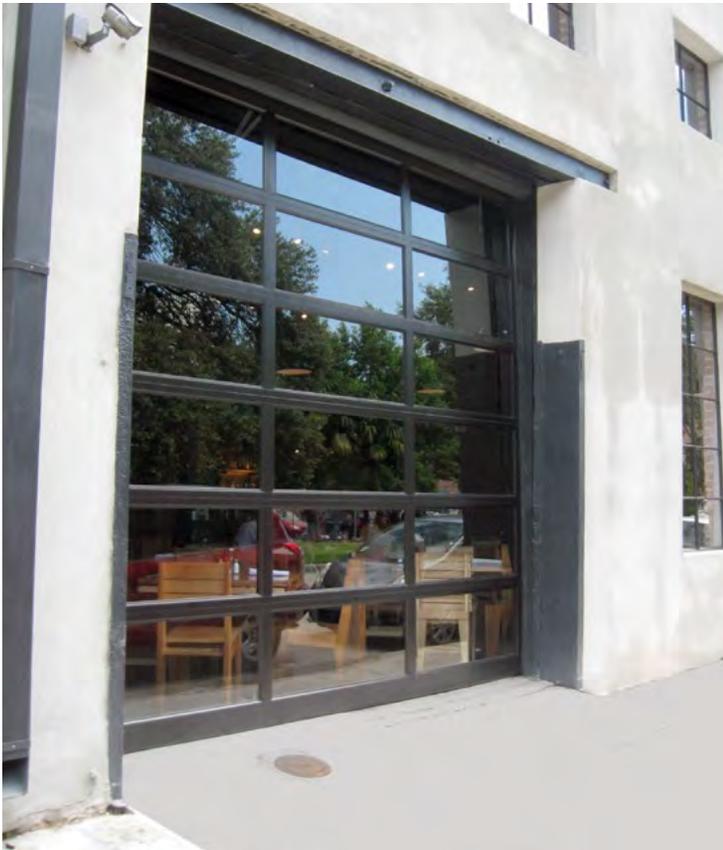
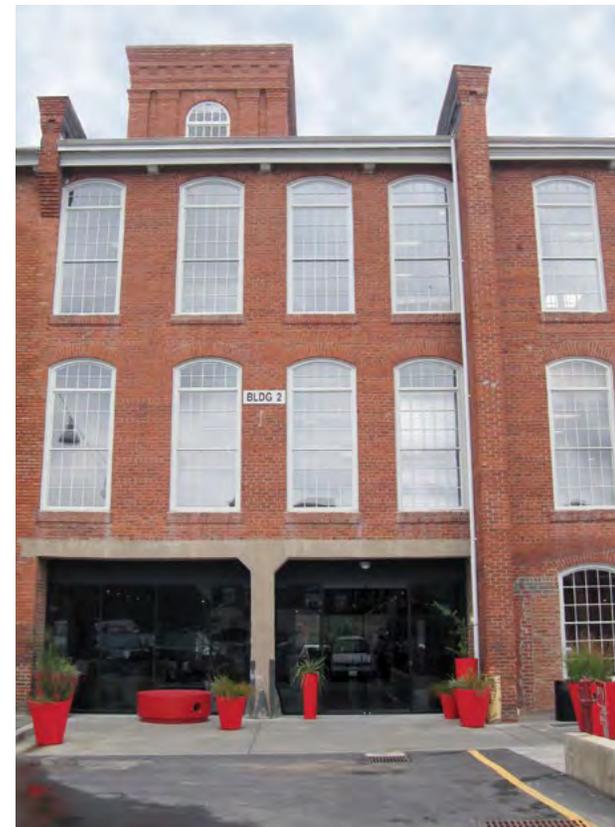
[25] The new infill designs for the garage door openings in this commercial building (a) converted for restaurant use and in this mill building (b) rehabilitated for residential use are compatible with the historic character of the buildings.

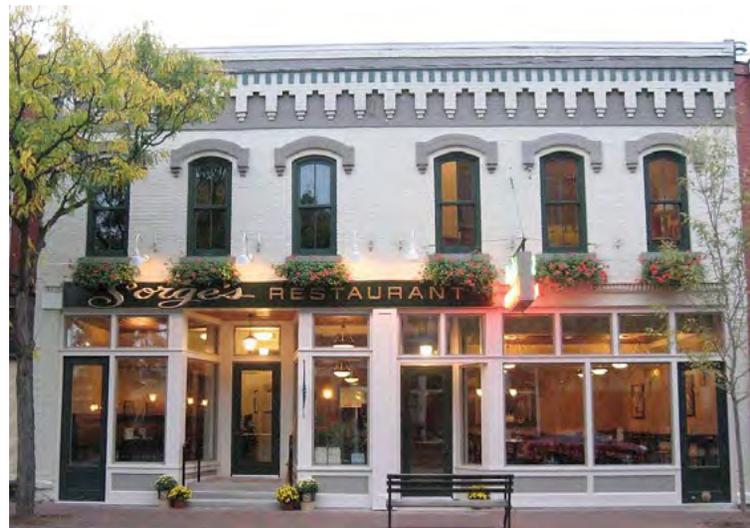
[28] This new storefront, which replaced one that was missing, is compatible with the historic character of the building.

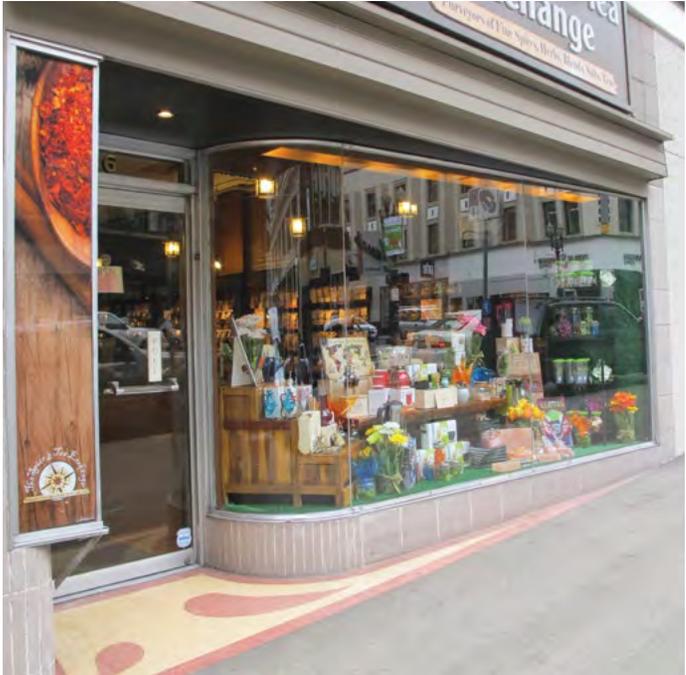
[27] This original c. 1940s storefront, with its character-defining angled and curved glass display window and recessed entrance with a decorative terrazzo paving, is in good condition and should be retained in a rehabilitation project.

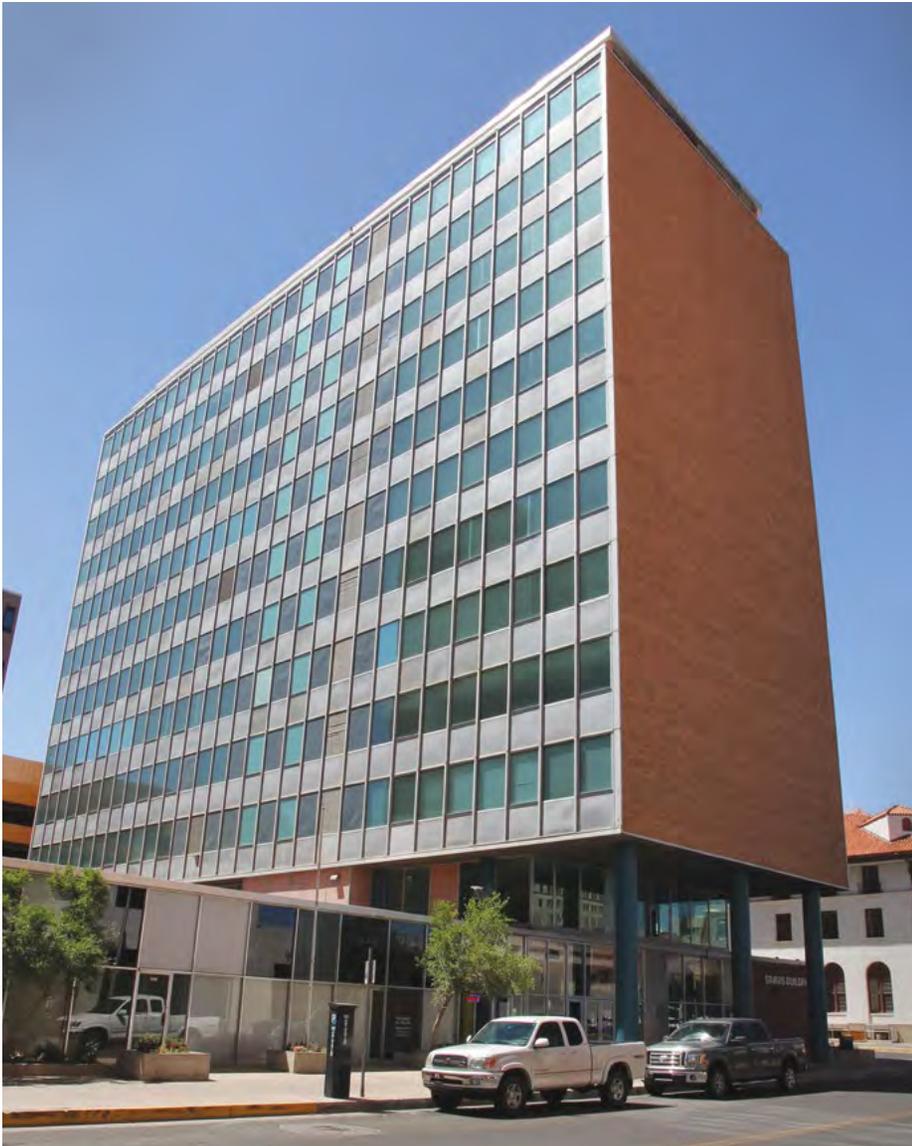
[30] Rather than replace the original curtain wall system of the 1954 Simms Building in Albuquerque, NM, with a different color tinted glass or coat it with a non-historic reflective film, the HVAC system was updated to improve energy efficiency. Photo: Harvey M. Kaplan.

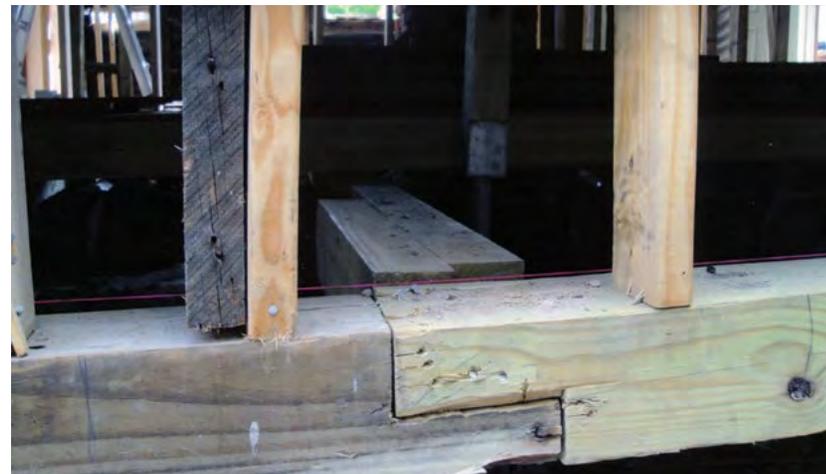
[33] Retaining as much as possible of the historic wood sill plate and replacing only the termite-damaged wood is always the preferred and recommended treatment.

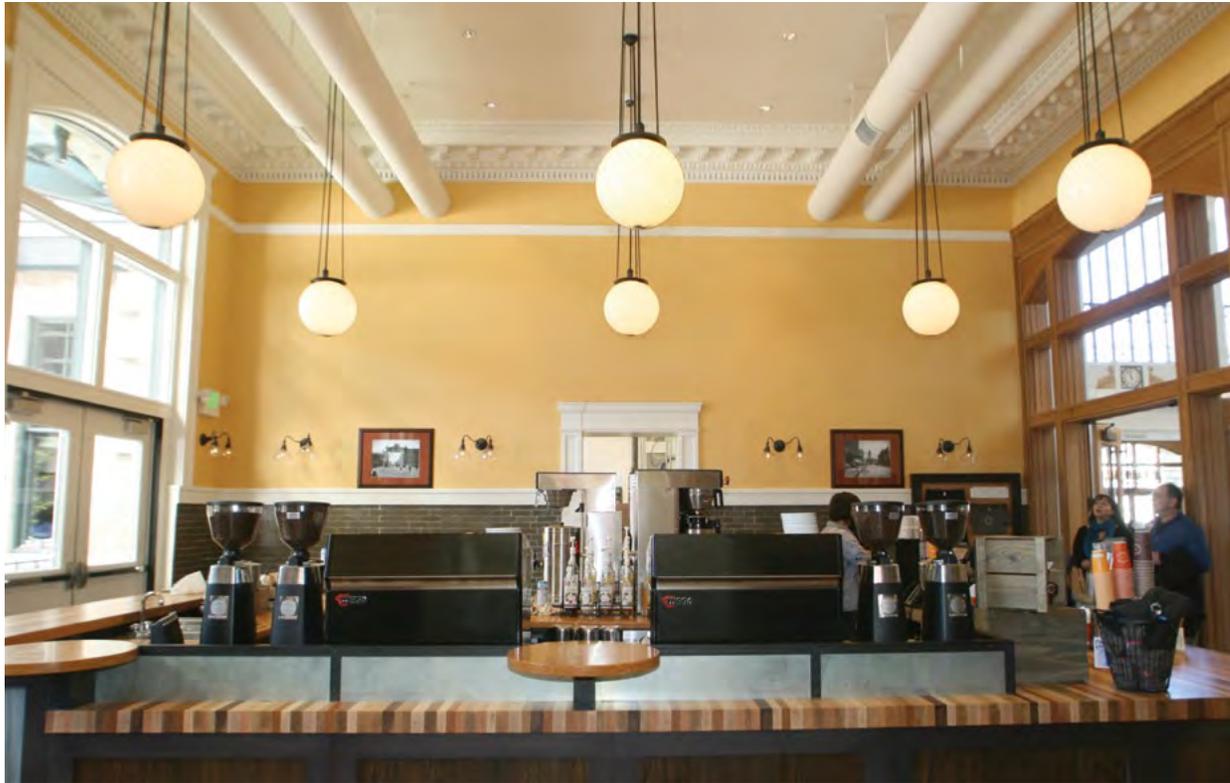
[37] Exposed and painted ducts were appropriately installed here in a retail space in Denver's historic Union Station after considering other options that would have impacted the ceiling height, or damaged or obscured the ornamental plaster crown molding. *Photo: Heritage Consulting Group.*

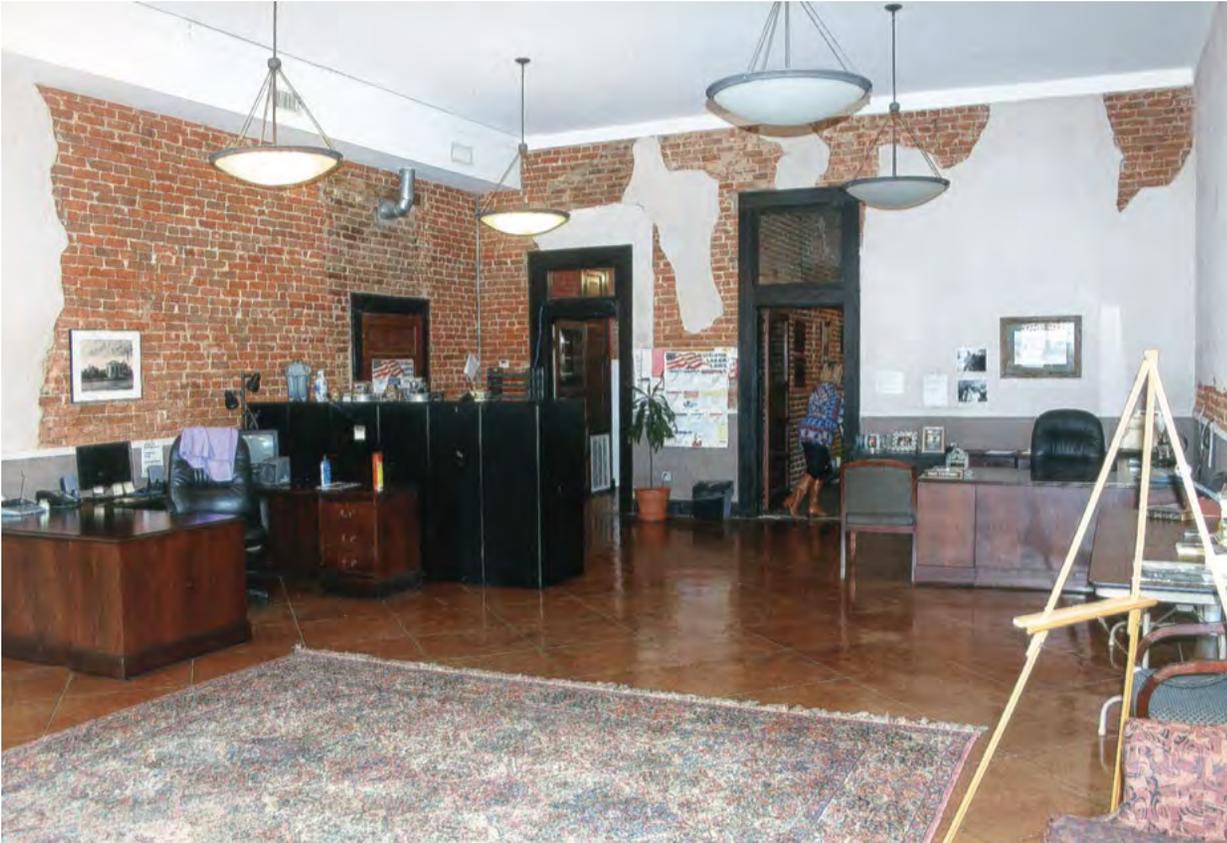
[41] Not Recommended: Leaving fragments of deteriorated or “sculpted” plaster is not a compatible treatment for either finished or unfinished interior spaces.

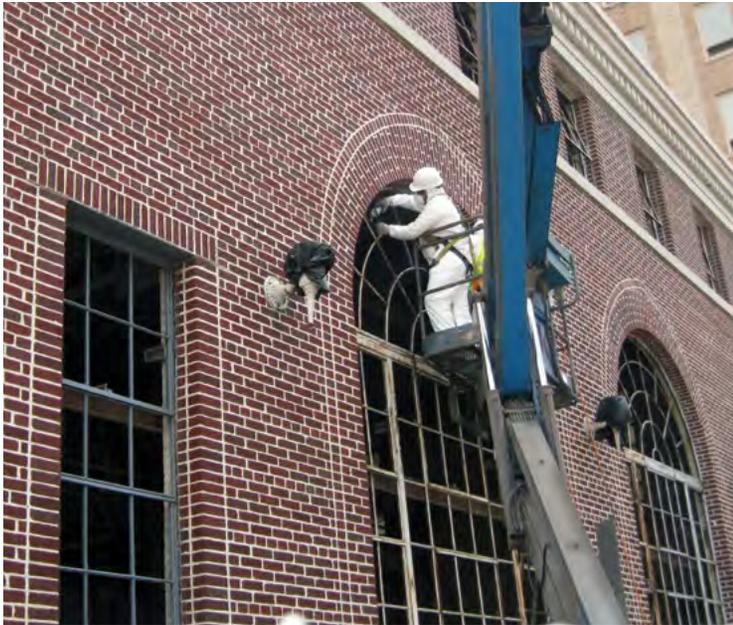
[57] Workers wear protective clothing while removing lead paint from metal features.

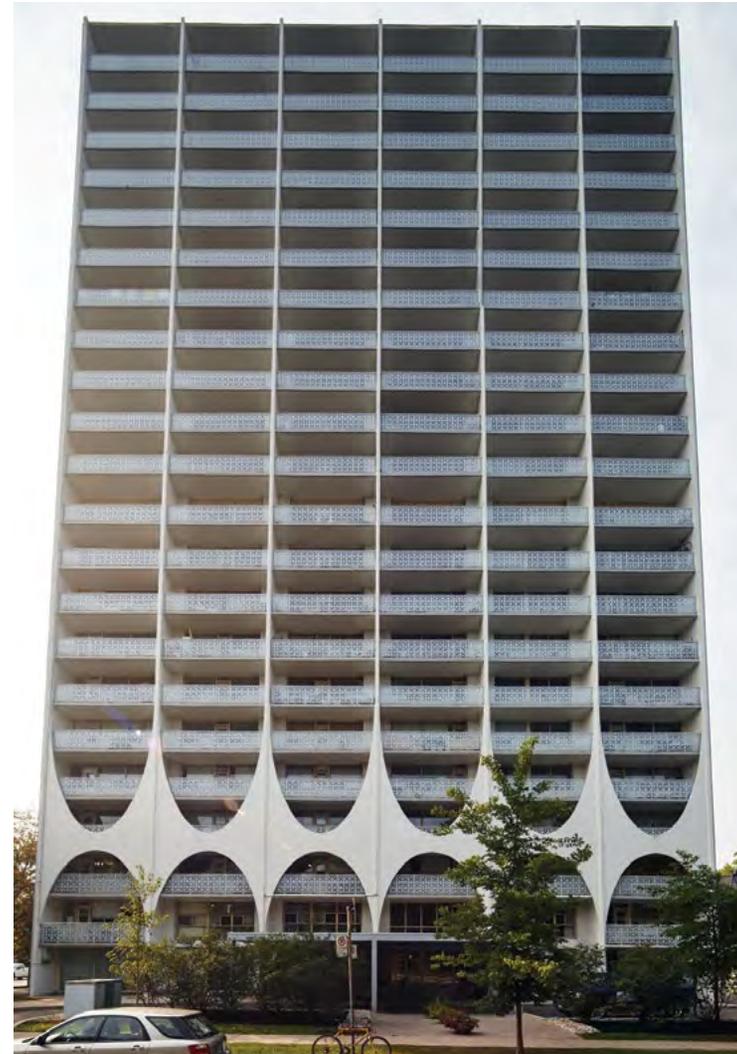
[59] (a-b) The decorative concrete balcony railings on this 1960s building did not meet life-safety code requirements. They were replaced with new glass railings with a fritted glass pattern matching the original design—a creative solution that satisfies codes, while preserving the historic appearance of the building when viewed from the street (c-d). Photos: (a, b, d) ERA Architects, Inc.; (c) Nathan Cyprys, photographer.

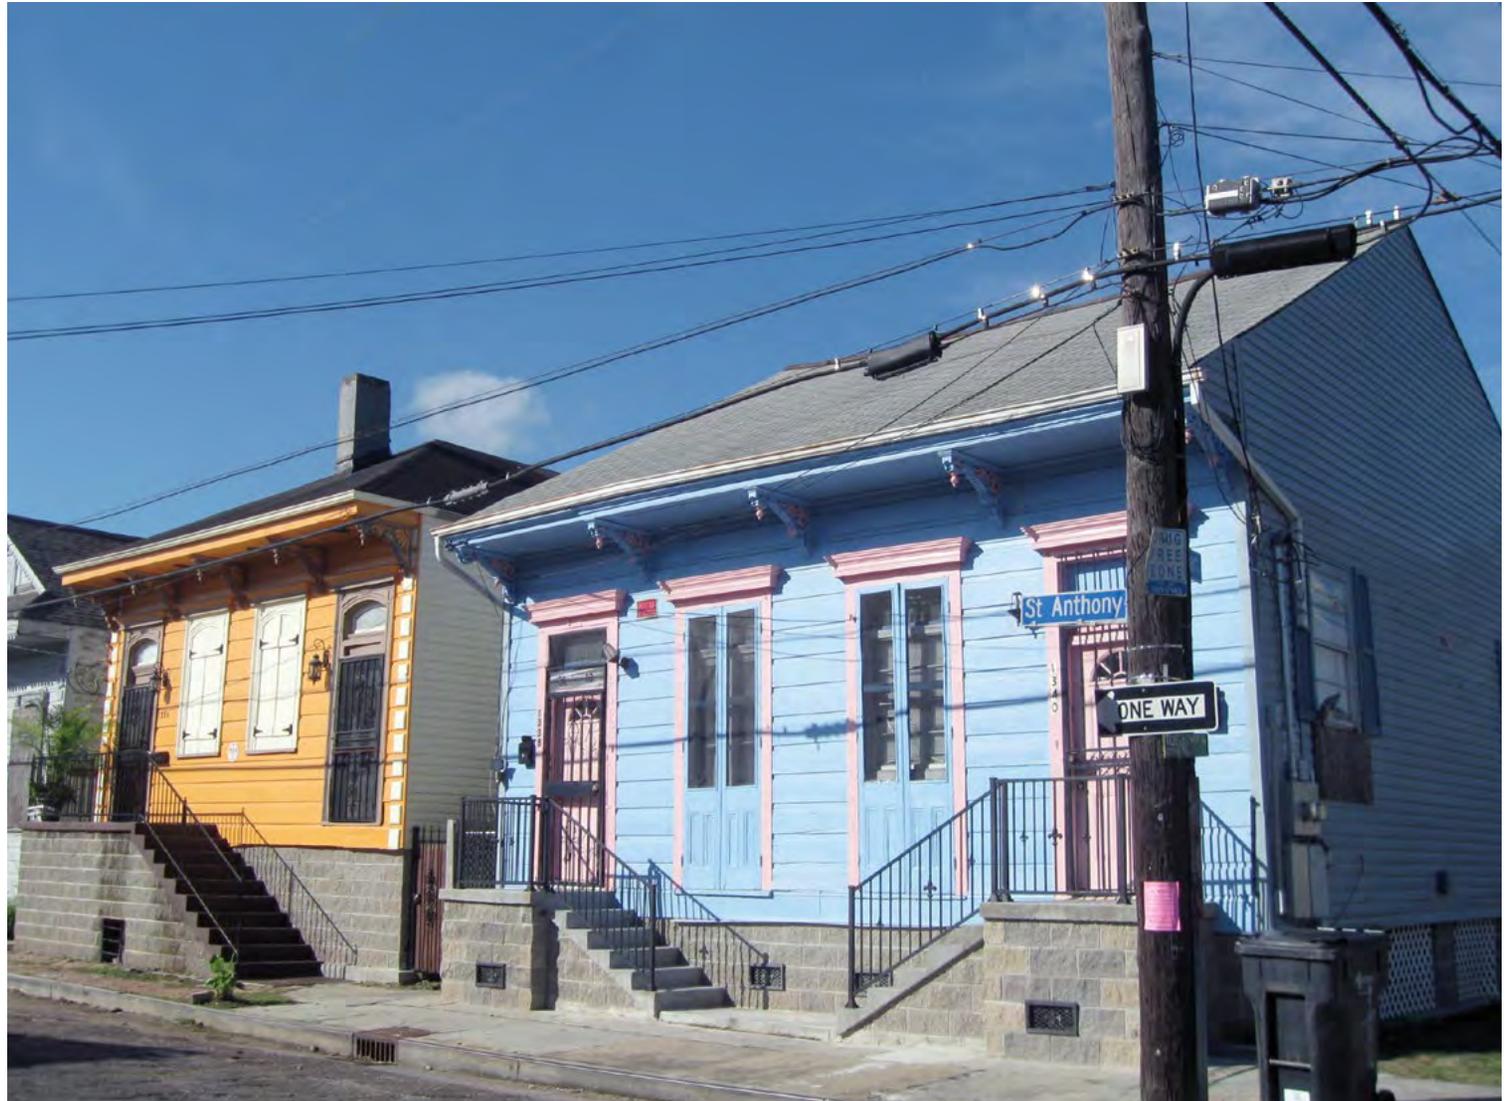
[60] In some instances, it may be necessary to elevate a historic building located in a floodplain to protect it. But this treatment is appropriate only if elevating the building will retain its historic character, including its relationship to the site, and its new height will be compatible with surrounding buildings if in a historic district. The house on the right, which has been raised only slightly, has retained its historic character. The house on the left has been raised several feet higher, resulting in a greater impact on the historic character of the house and the district.

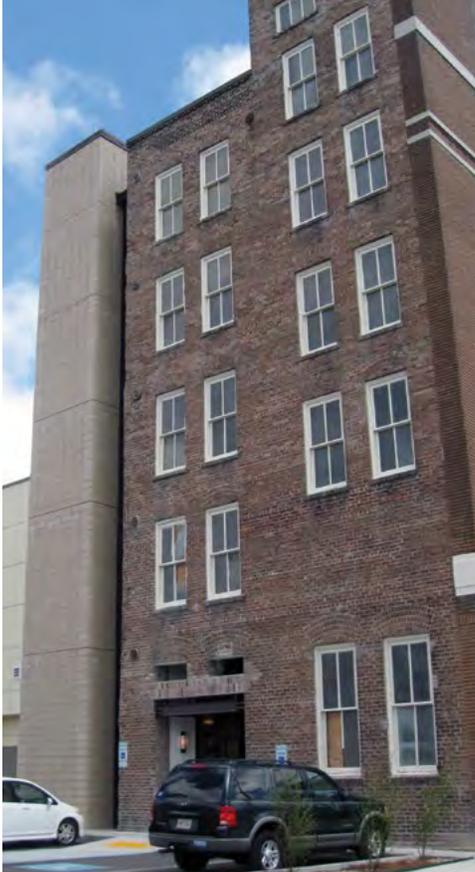
[62] The stair tower at the rear of this commercial building is a compatible new addition.
