THE SECRETARY
OF THE INTERIOR'S
STANDARDS FOR
THE TREATMENT
OF HISTORIC
PROPERTIES

WITH
**GUIDELINES FOR
PRESERVING,
REHABILITATING,
RESTORING &
RECONSTRUCTING
HISTORIC
BUILDINGS**

U.S. Department of the Interior
National Park Service
Technical Preservation Services

STANDARDS FOR REHABILITATION & GUIDELINES
FOR REHABILITATING HISTORIC BUILDINGS

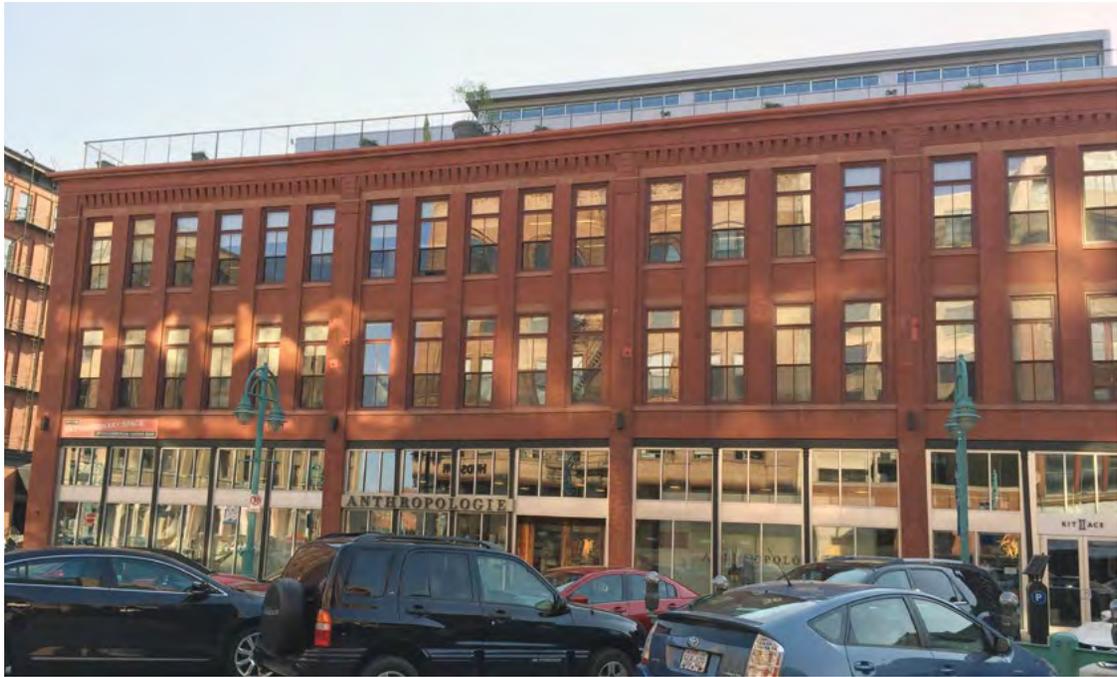
[64] Not Recommended:
It is generally not appropriate to construct a rooftop addition on a low-rise, two- to three-story building such as this, because it negatively affects its historic character.
