THE SECRETARY
OF THE INTERIOR'S
**STANDARDS FOR
THE TREATMENT
OF HISTORIC
PROPERTIES**

WITH
**GUIDELINES FOR
PRESERVING,
REHABILITATING,
RESTORING &
RECONSTRUCTING
HISTORIC
BUILDINGS**

U.S. Department of the Interior
National Park Service
Technical Preservation Services

2017

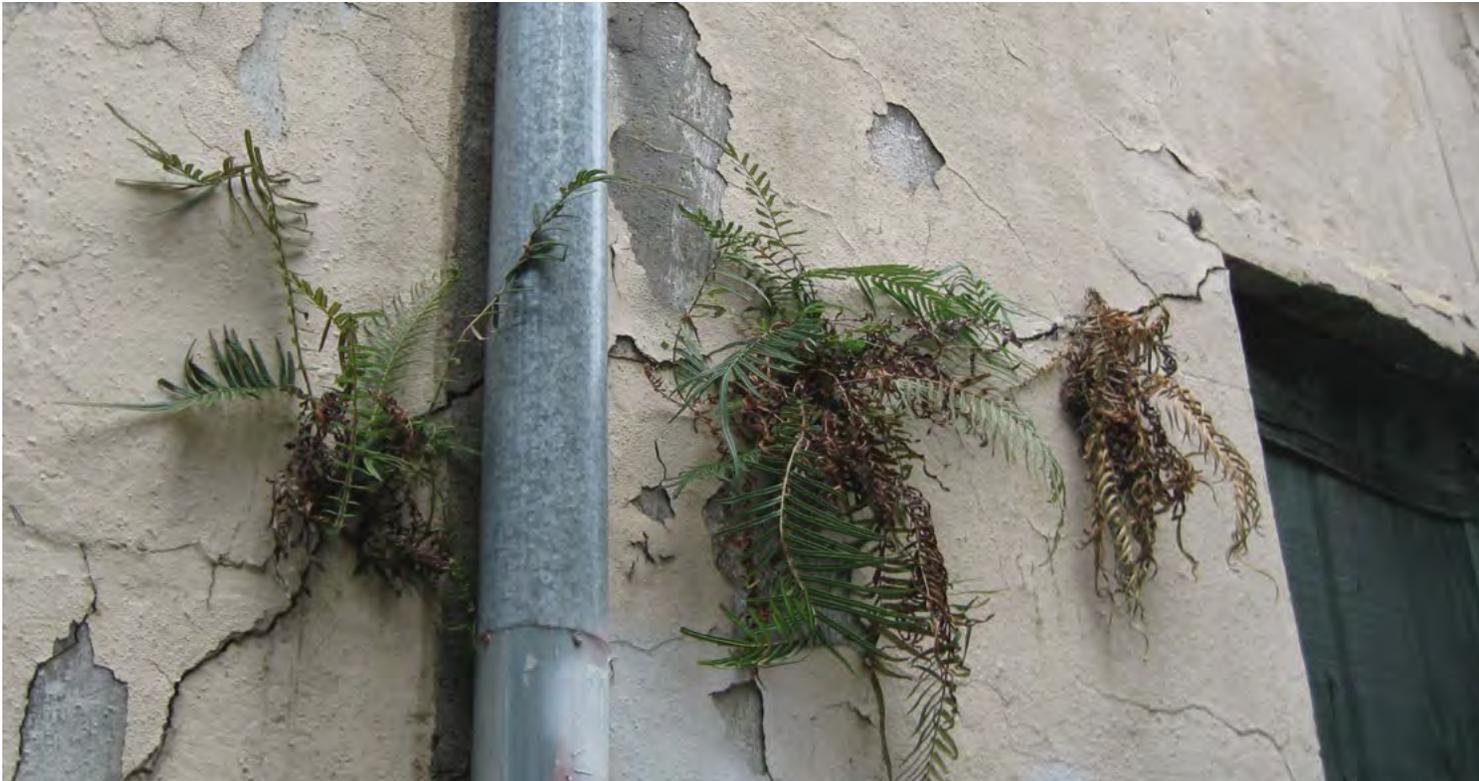
[3] **Not Recommended:** Cracks in the stucco have not been repaired, thereby allowing ferns to grow in the moist substrate which will cause further damage to the masonry.

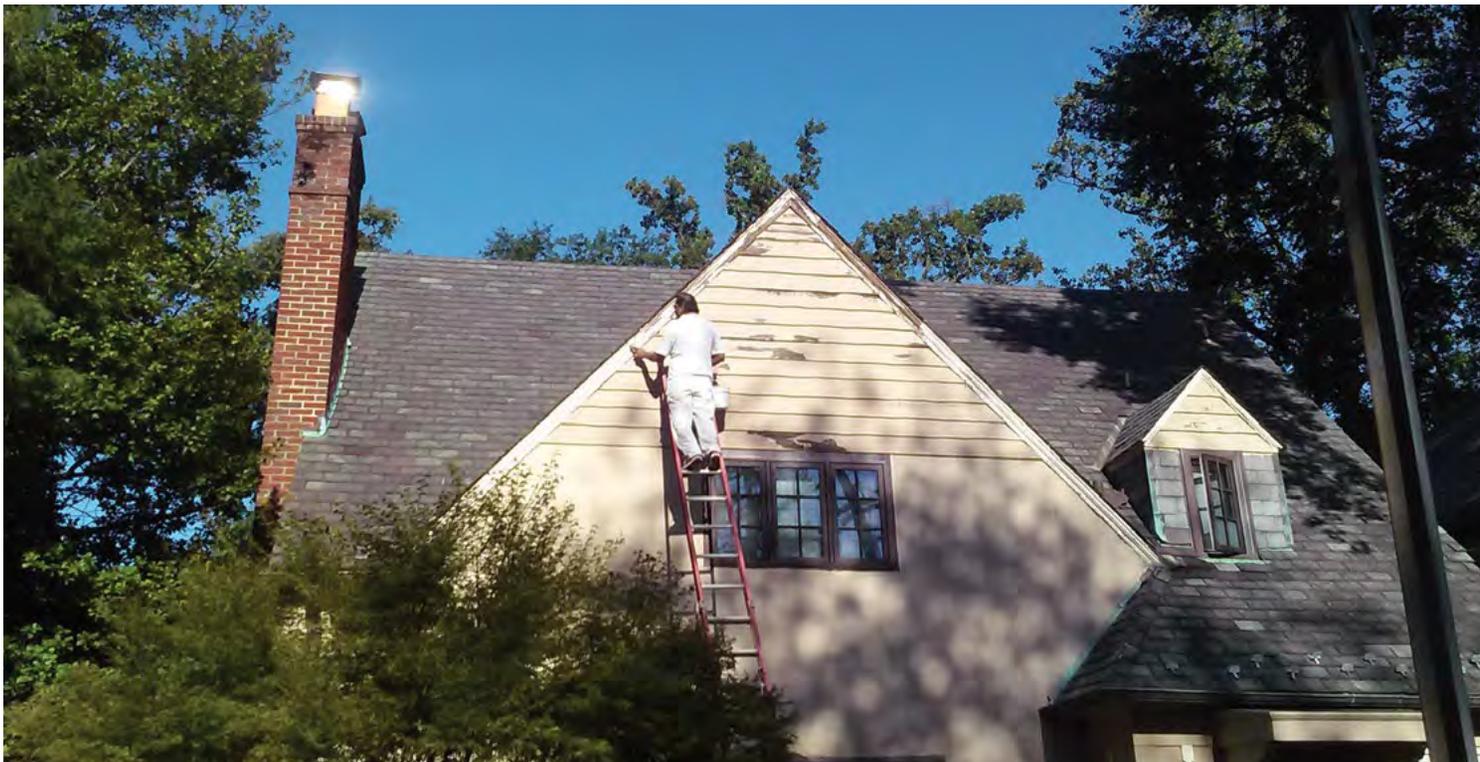
[4] Hand scraping to remove peeling paint from wood siding in preparation for repainting is an important part of regularly-scheduled maintenance.

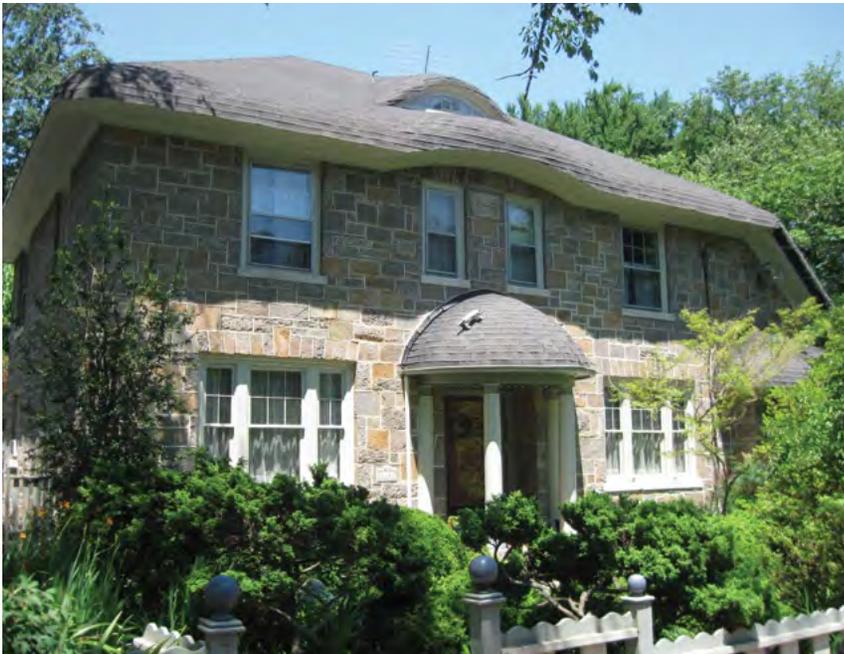
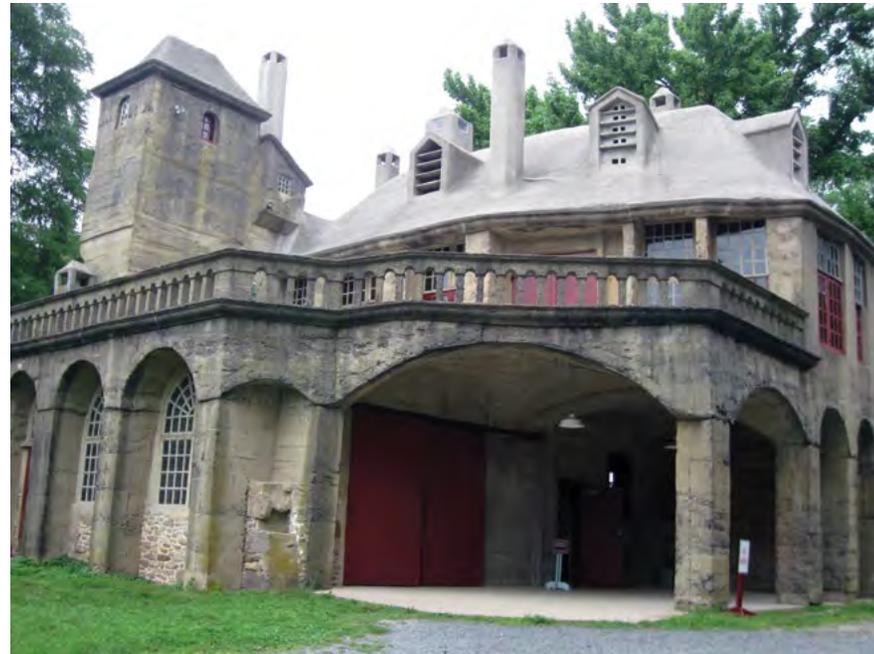
[9] Distinctively-shaped roofs are important in defining the historic character of these early 20th-century structures: (a) an asphalt shingle roof on a house; (b) and a concrete roof on Fonthill, Doylestown, PA (1908-1912), designed and built by Henry Chapman Mercer.

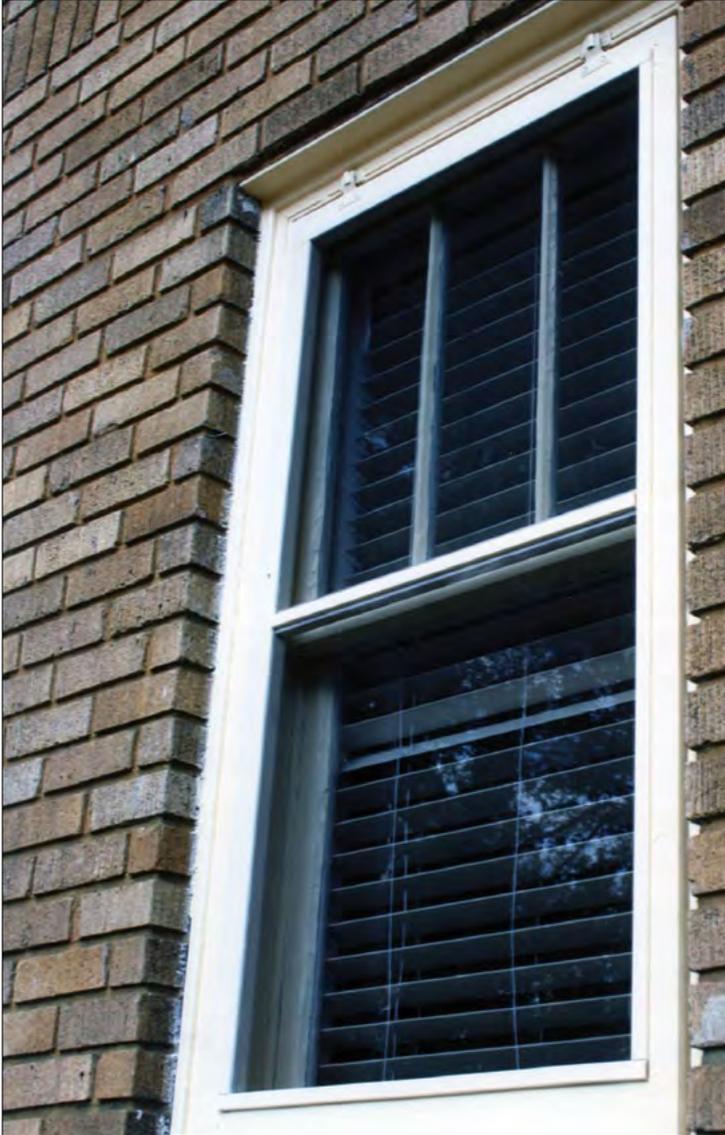
[10] Historic exterior storm windows preserve and help to insulate wood windows.

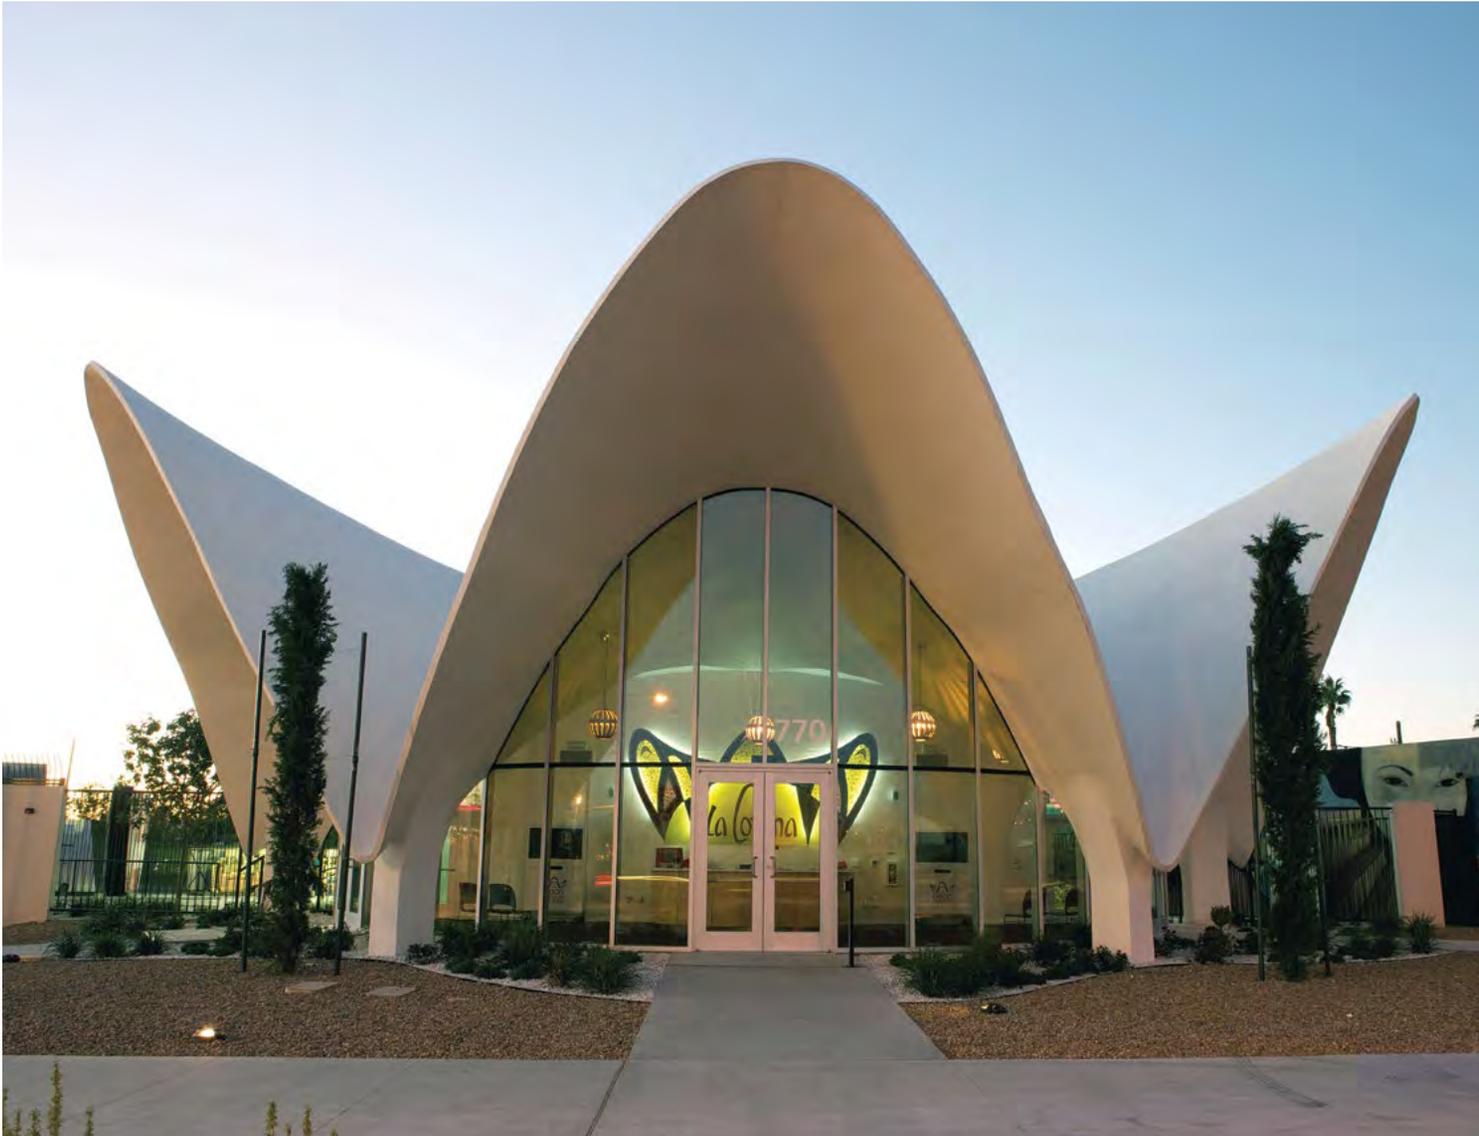
[2] Mid-century modern building technology made possible the form of this parabolic-shaped structure and its thin concrete shell construction. Built in 1961 as the lobby of the La Concha Motel in Las Vegas, it was designed by Paul Revere Williams, one of the first prominent African-American architects. It was moved to a new location and rehabilitated to serve as the Neon Museum, and is often cited as an example of Googie architecture. *Credit: Photographed with permission at The Neon Museum, Las Vegas, Nevada.*

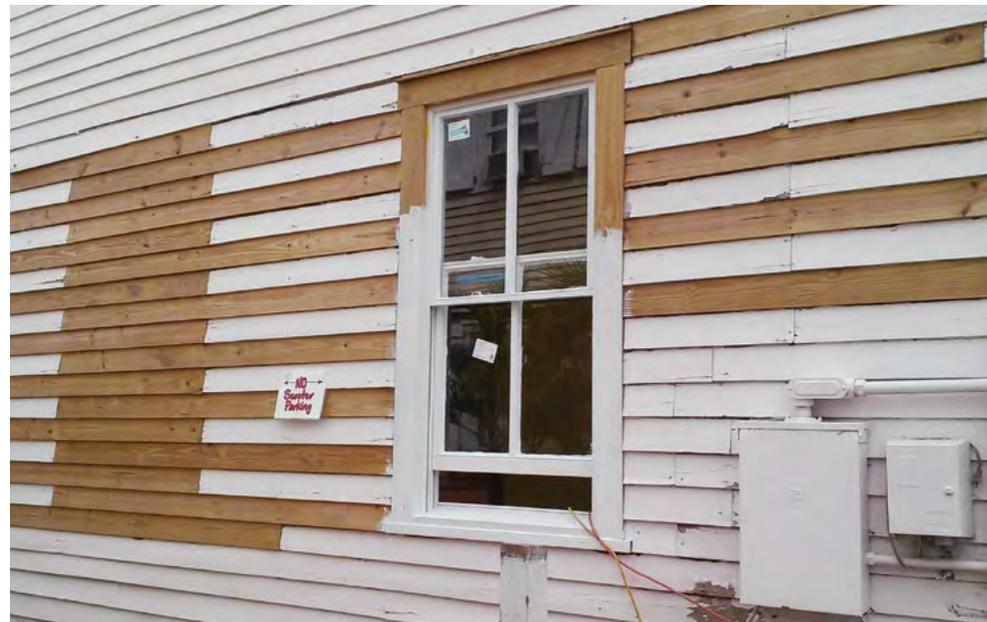
[8] Rotted clapboards have been replaced selectively with new wood siding to match the originals.

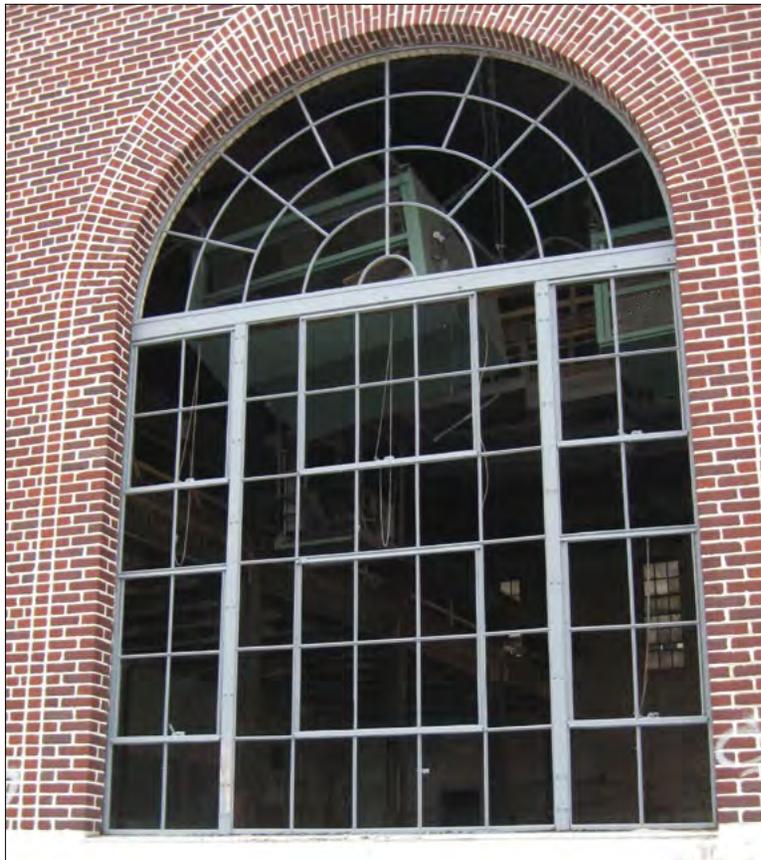
[12] This historic steel window has been cleaned, repaired, and primed in preparation for painting and reglazing.

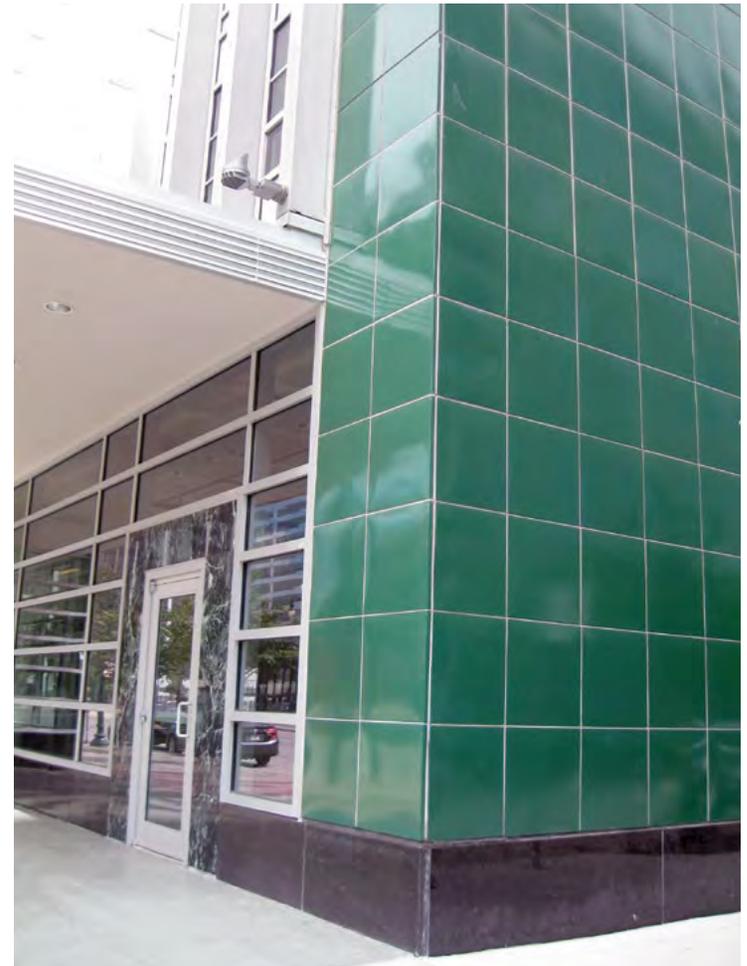
[15] New enameled-metal panels were replicated to replace the original panels, which were too deteriorated to repair, when the storefront of this early 1950s building was recreated.

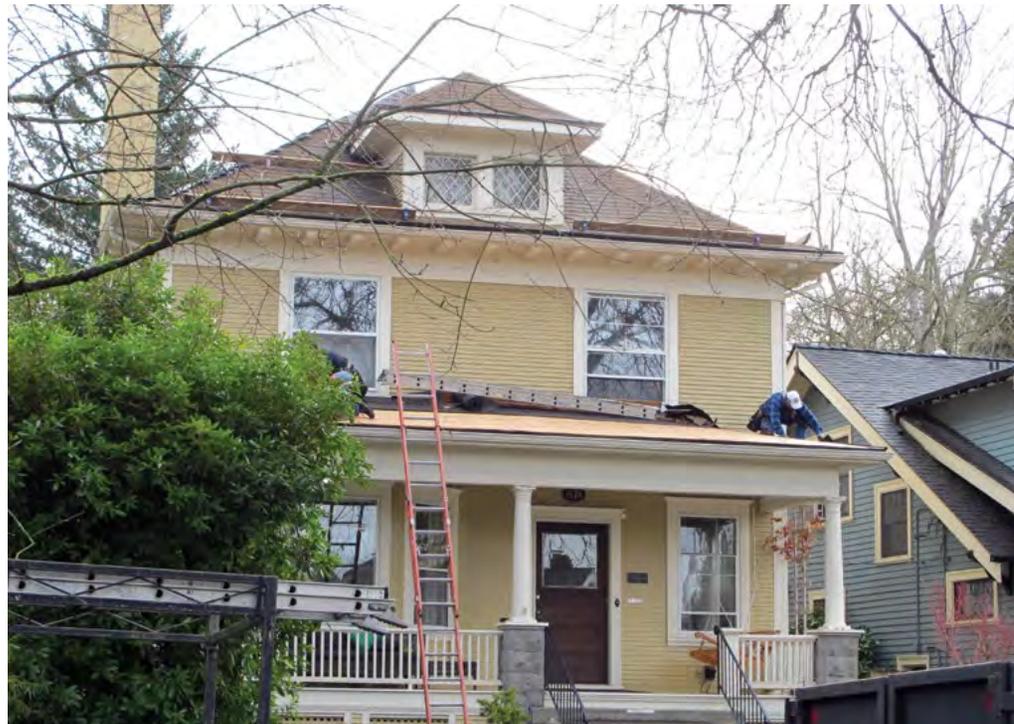
[16] The deteriorated asphalt shingles of this porch roof are being replaced in kind with matching shingles.

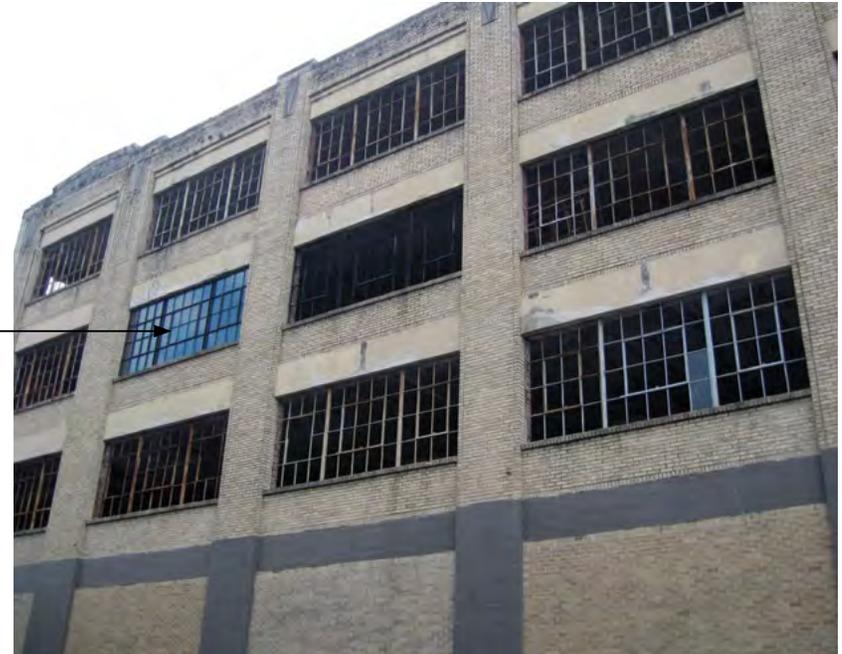
[19] Installing a mockup of a proposed replacement window can be helpful to evaluate how well the new windows will match the historic windows that are missing or too deteriorated to repair.

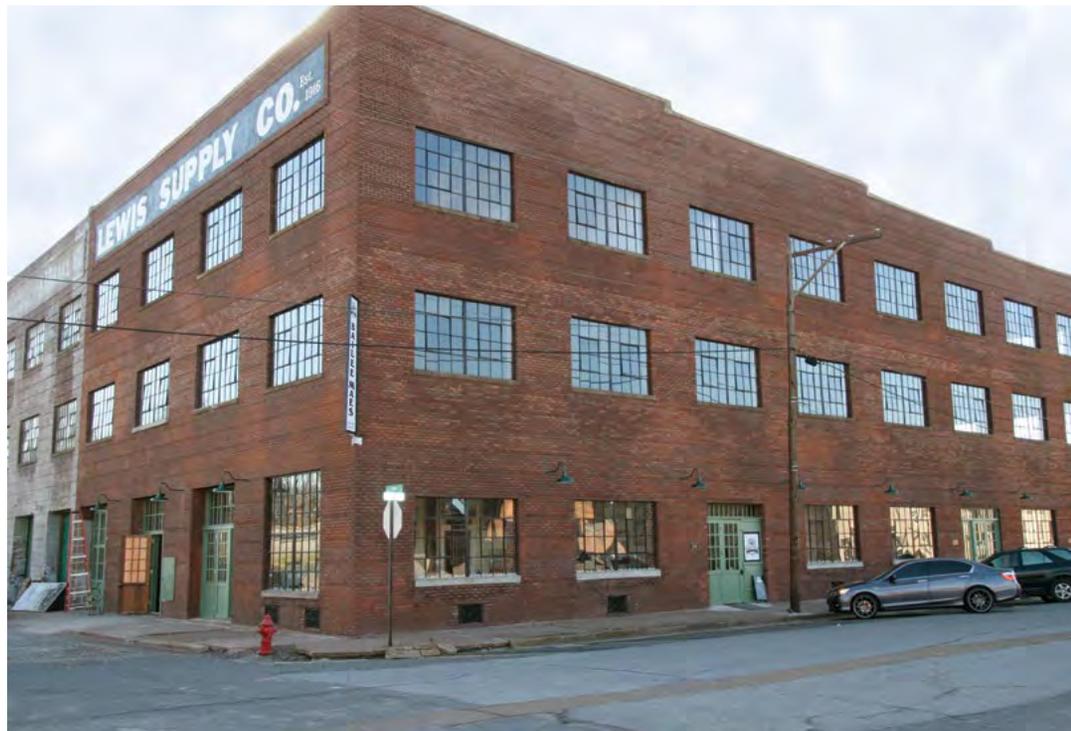
[20 a-d] The original steel windows in this industrial building were successfully repaired as part of the rehabilitation project (left).

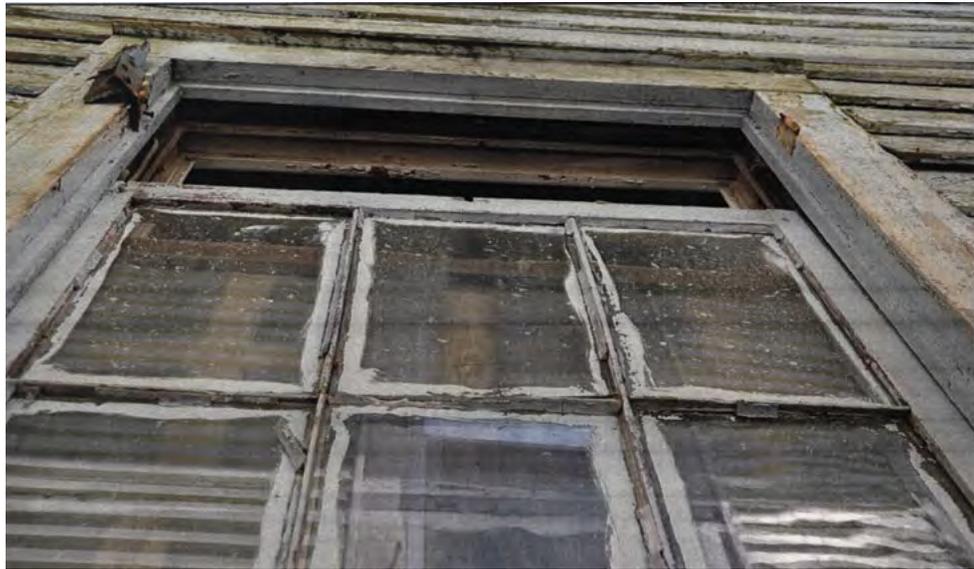
[23] (a) This deteriorated historic wood window was repaired and retained (b) in this rehabilitation project.

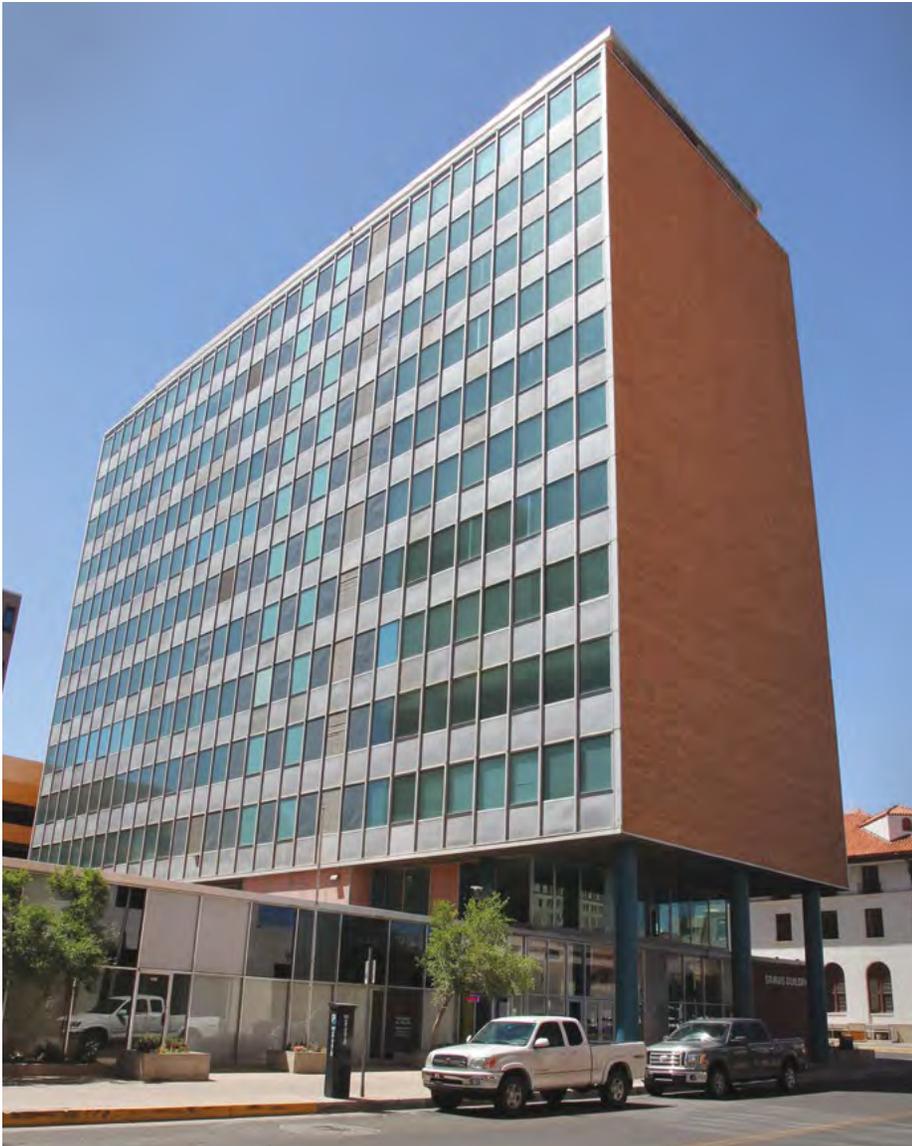
[30] Rather than replace the original curtain wall system of the 1954 Simms Building in Albuquerque, NM, with a different color tinted glass or coat it with a non-historic reflective film, the HVAC system was updated to improve energy efficiency. Photo: Harvey M. Kaplan.

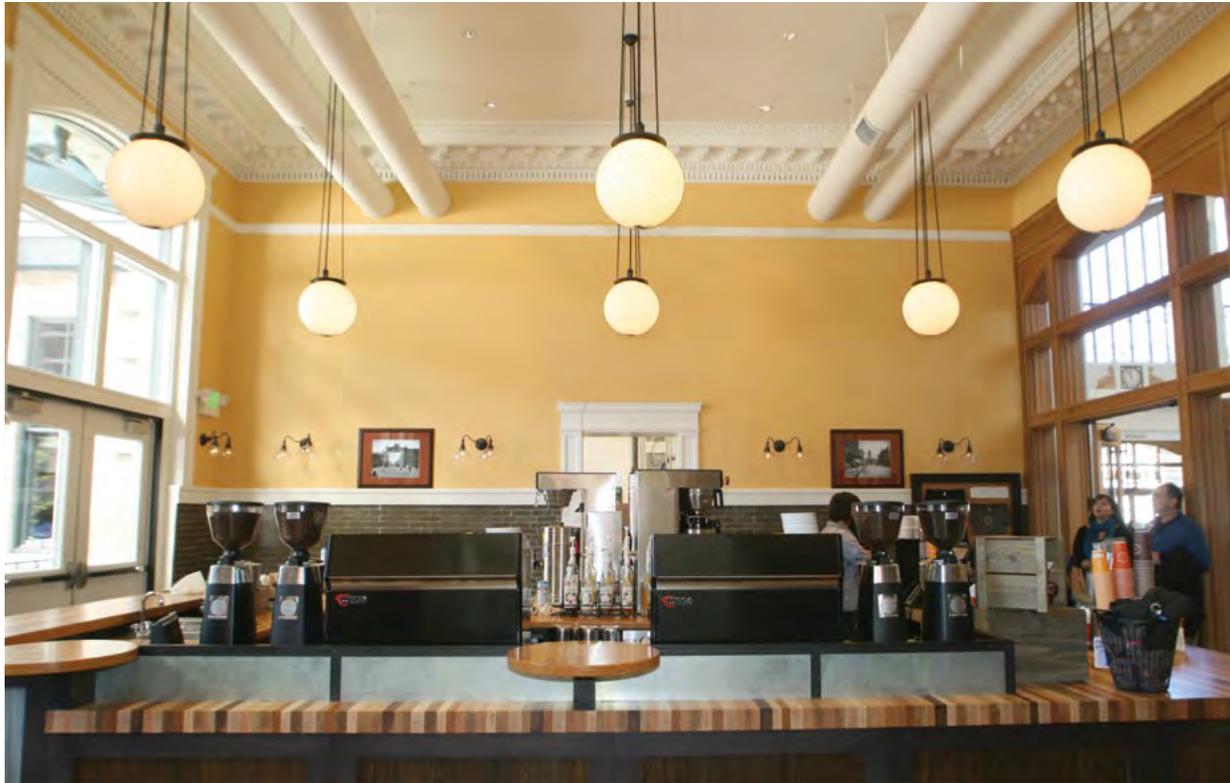
[37] Exposed and painted ducts were appropriately installed here in a retail space in Denver's historic Union Station after considering other options that would have impacted the ceiling height, or damaged or obscured the ornamental plaster crown molding. *Photo: Heritage Consulting Group.*

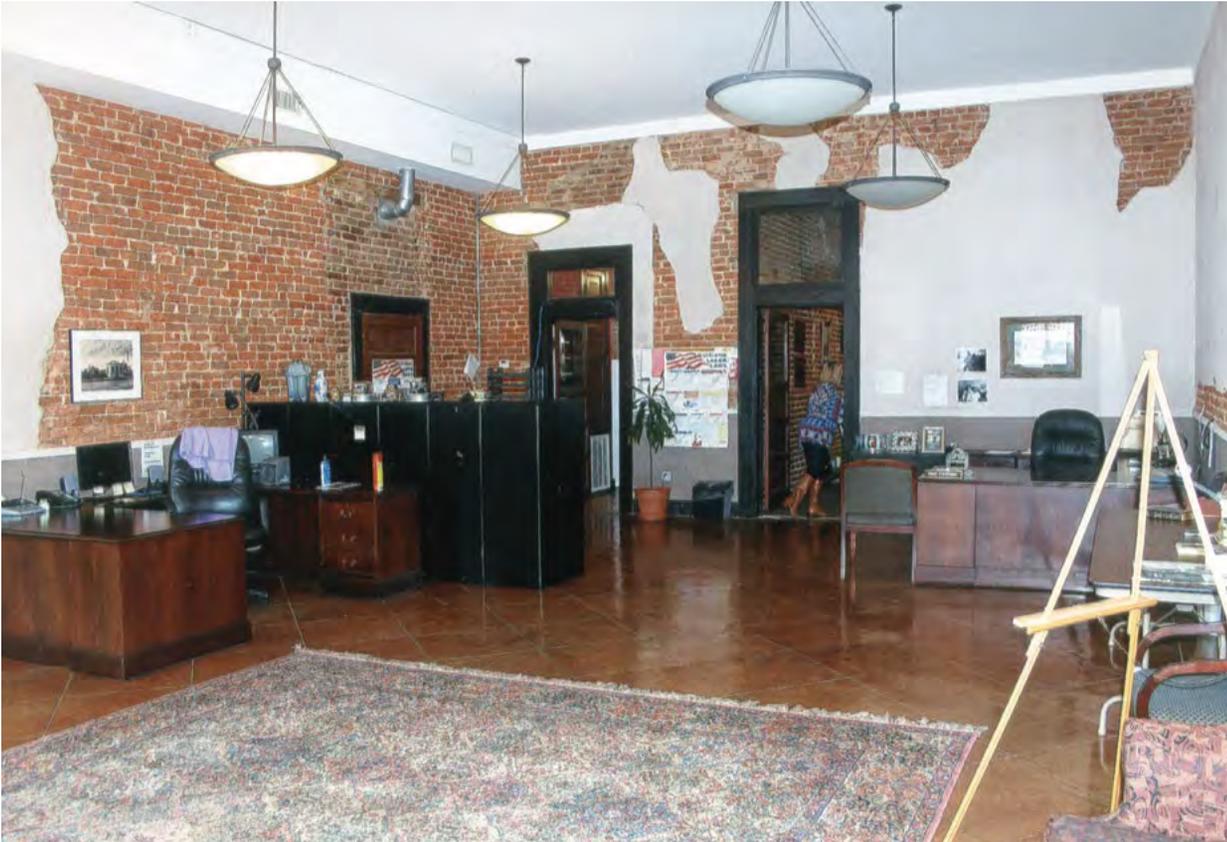
[41] Not Recommended: Leaving fragments of deteriorated or “sculpted” plaster is not a compatible treatment for either finished or unfinished interior spaces.

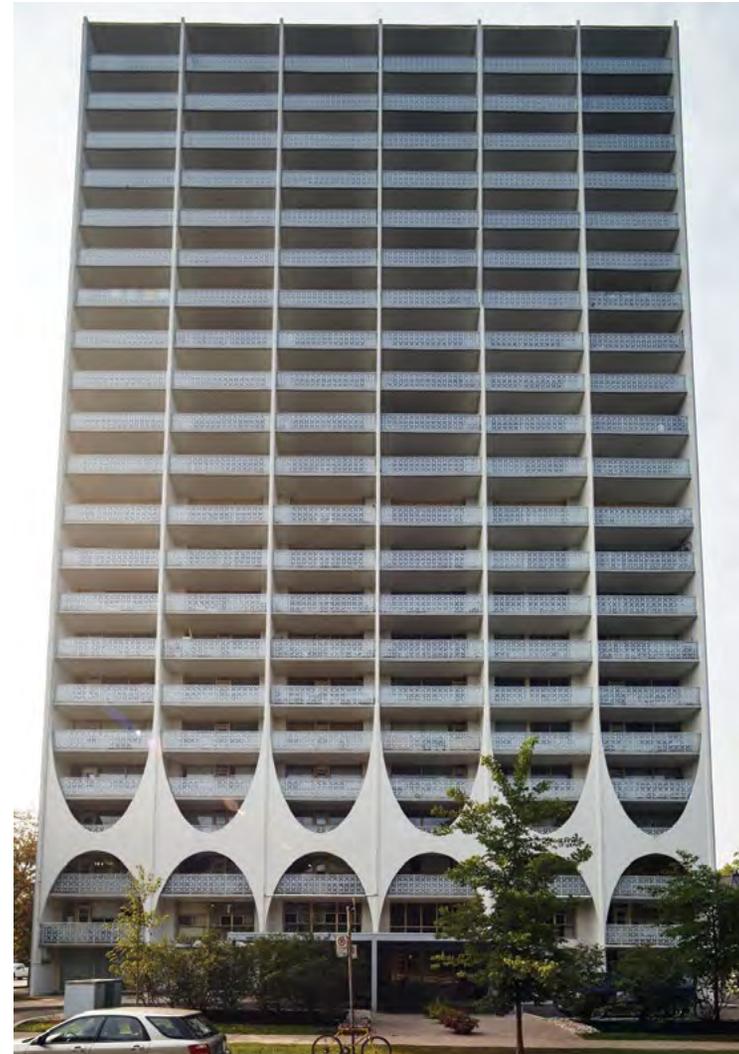
[59] (a-b) The decorative concrete balcony railings on this 1960s building did not meet life-safety code requirements. They were replaced with new glass railings with a fritted glass pattern matching the original design—a creative solution that satisfies codes, while preserving the historic appearance of the building when viewed from the street (c-d). Photos: (a, b, d) ERA Architects, Inc.; (c) Nathan Cyprys, photographer.

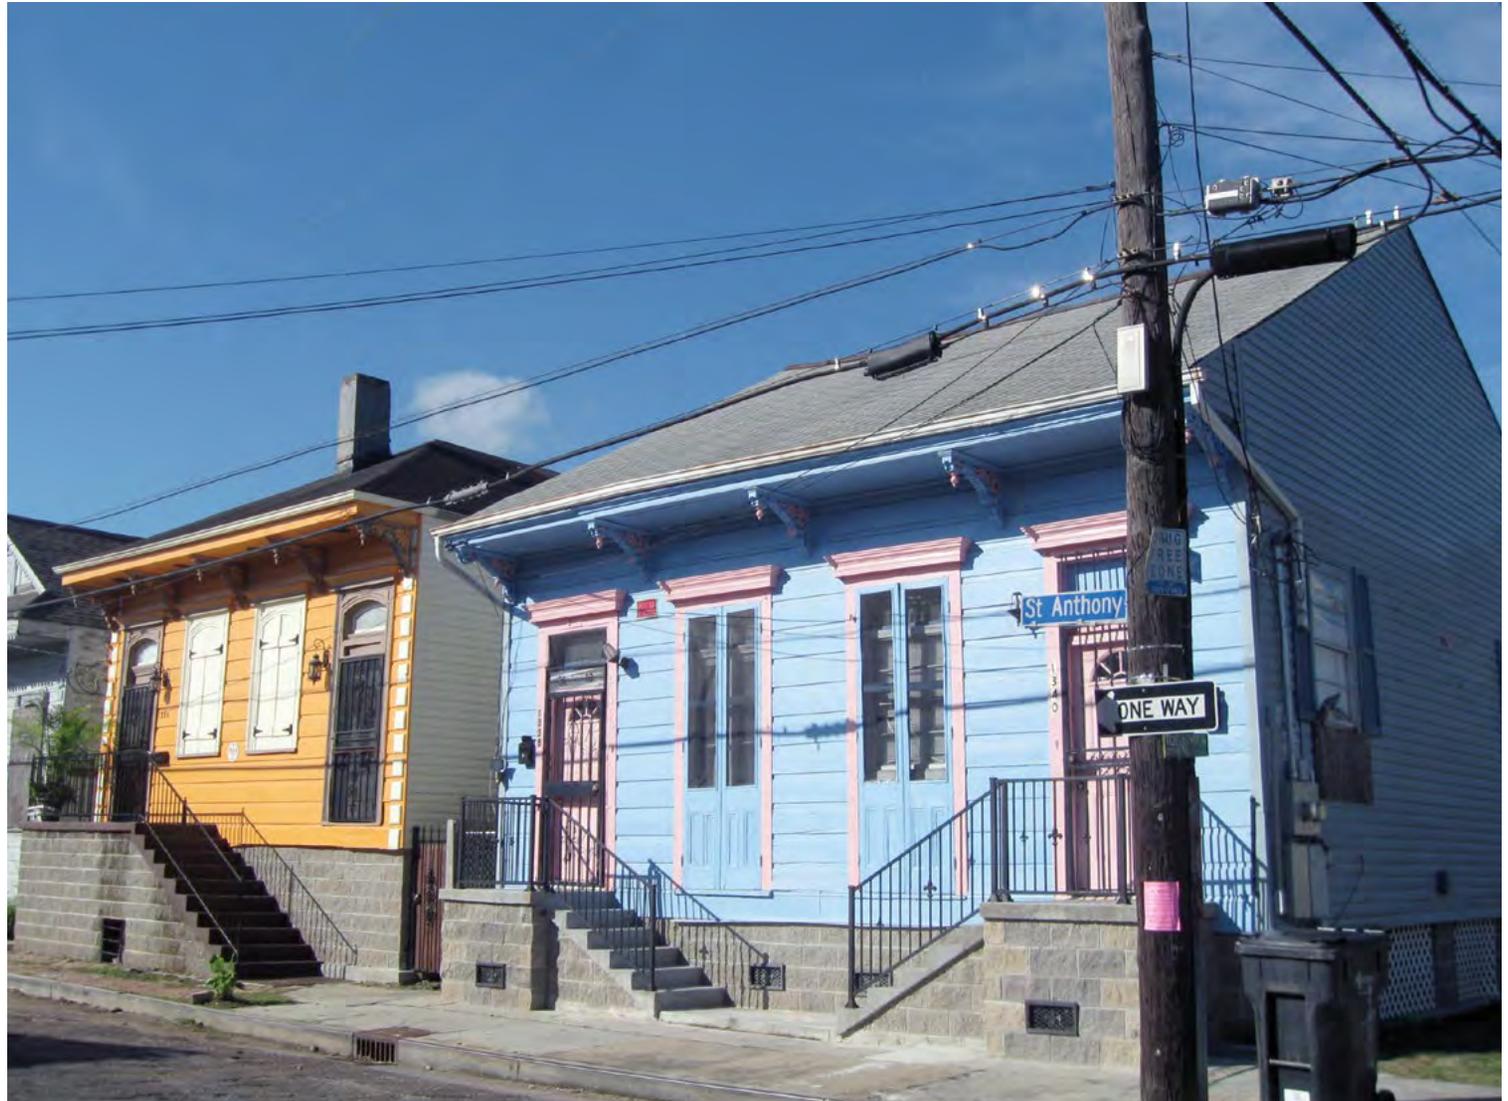
[60] In some instances, it may be necessary to elevate a historic building located in a floodplain to protect it. But this treatment is appropriate only if elevating the building will retain its historic character, including its relationship to the site, and its new height will be compatible with surrounding buildings if in a historic district. The house on the right, which has been raised only slightly, has retained its historic character. The house on the left has been raised several feet higher, resulting in a greater impact on the historic character of the house and the district.

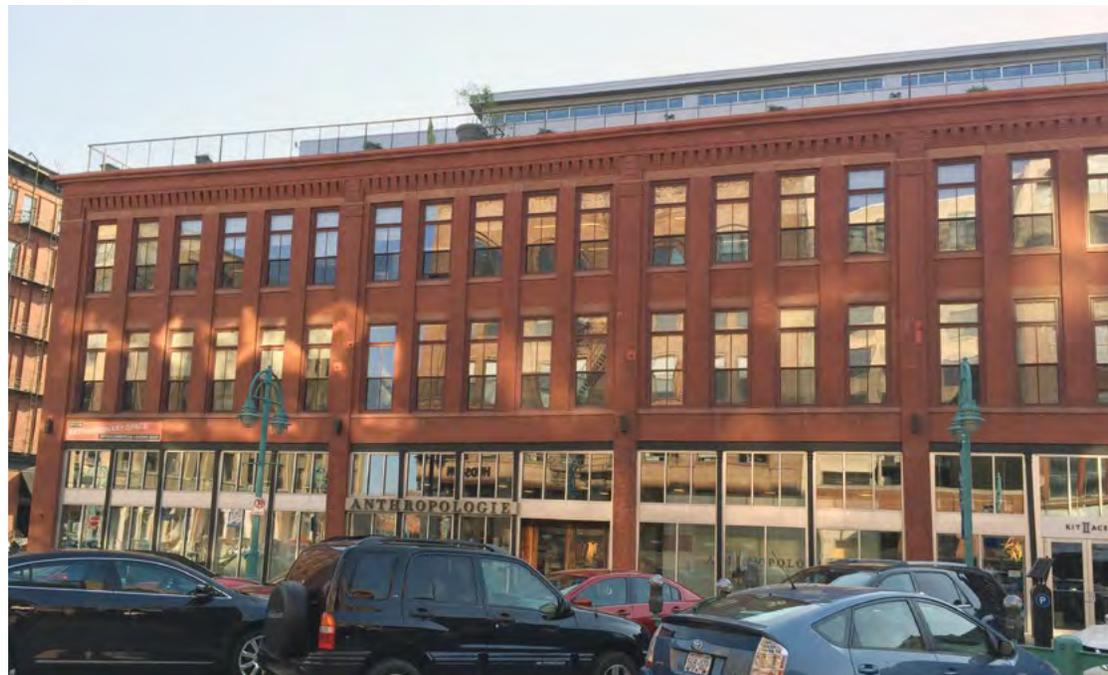
[64] Not Recommended:
It is generally not appropriate to construct a rooftop addition on a low-rise, two- to three-story building such as this, because it negatively affects its historic character.

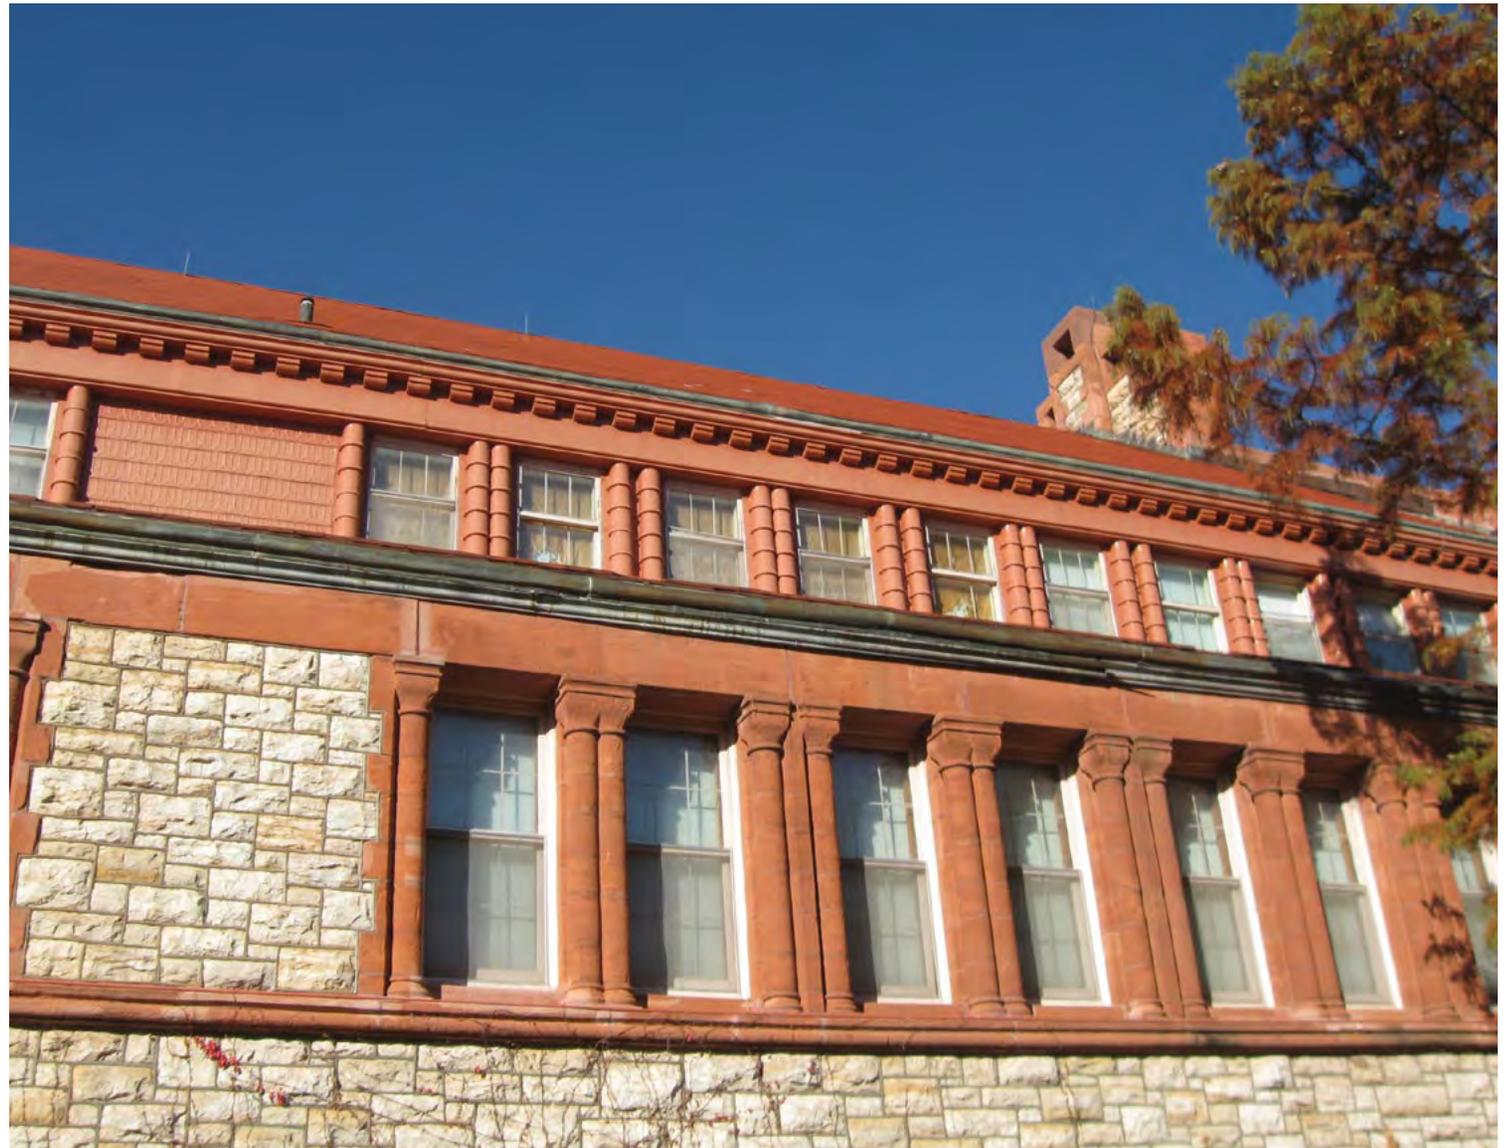
[6] Preliminary work before starting restoration revealed that the columns and the decorative shingles ornamenting the top floor of this historic building were fabricated of metal to imitate the red sandstone used elsewhere on the building.

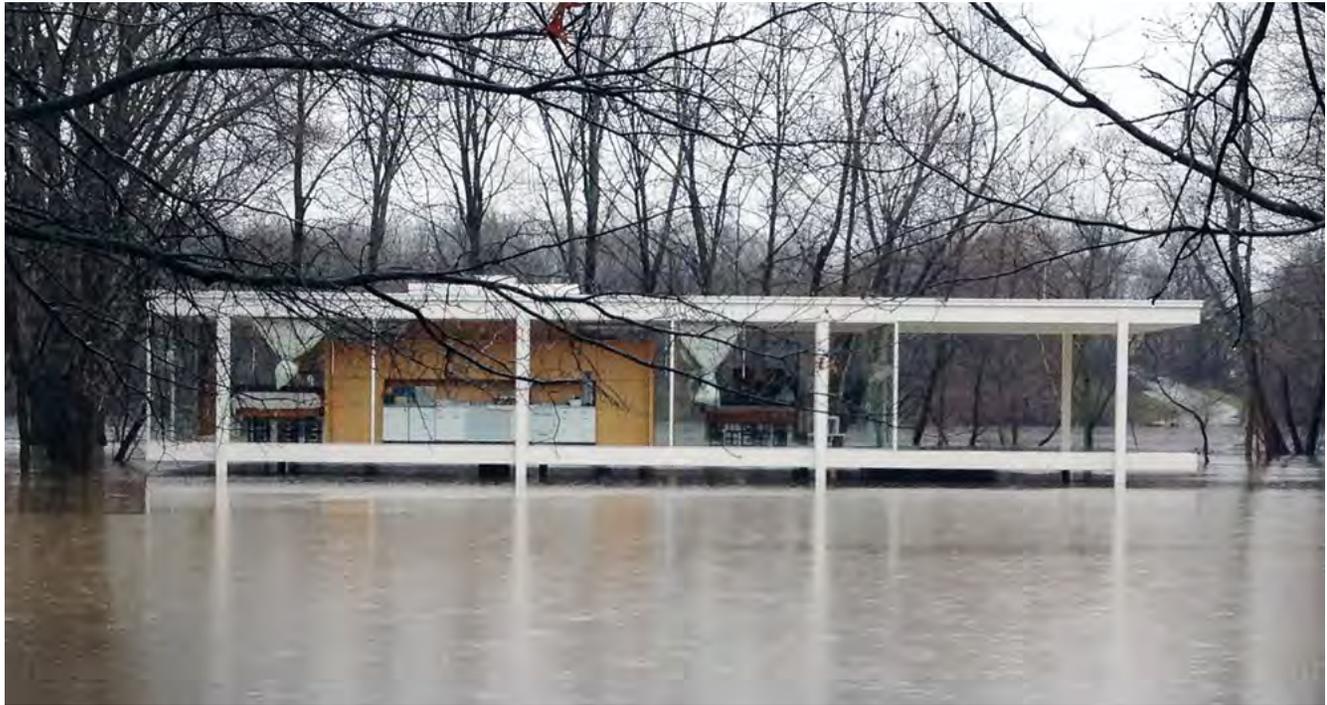
[19] The 1951 Mies van der Rohe-designed Farnsworth House, Plano, IL, was built close to the Fox River, which is increasingly prone to floods. To preserve the house in its original location, historic preservation architects and engineers continue to explore ways to protect it from the flooding, including a possible system that would lift the house above the flood waters and lower it back to the ground. *Photo: Courtesy Farnsworth, A Site of the National Trust for Historic Preservation.*

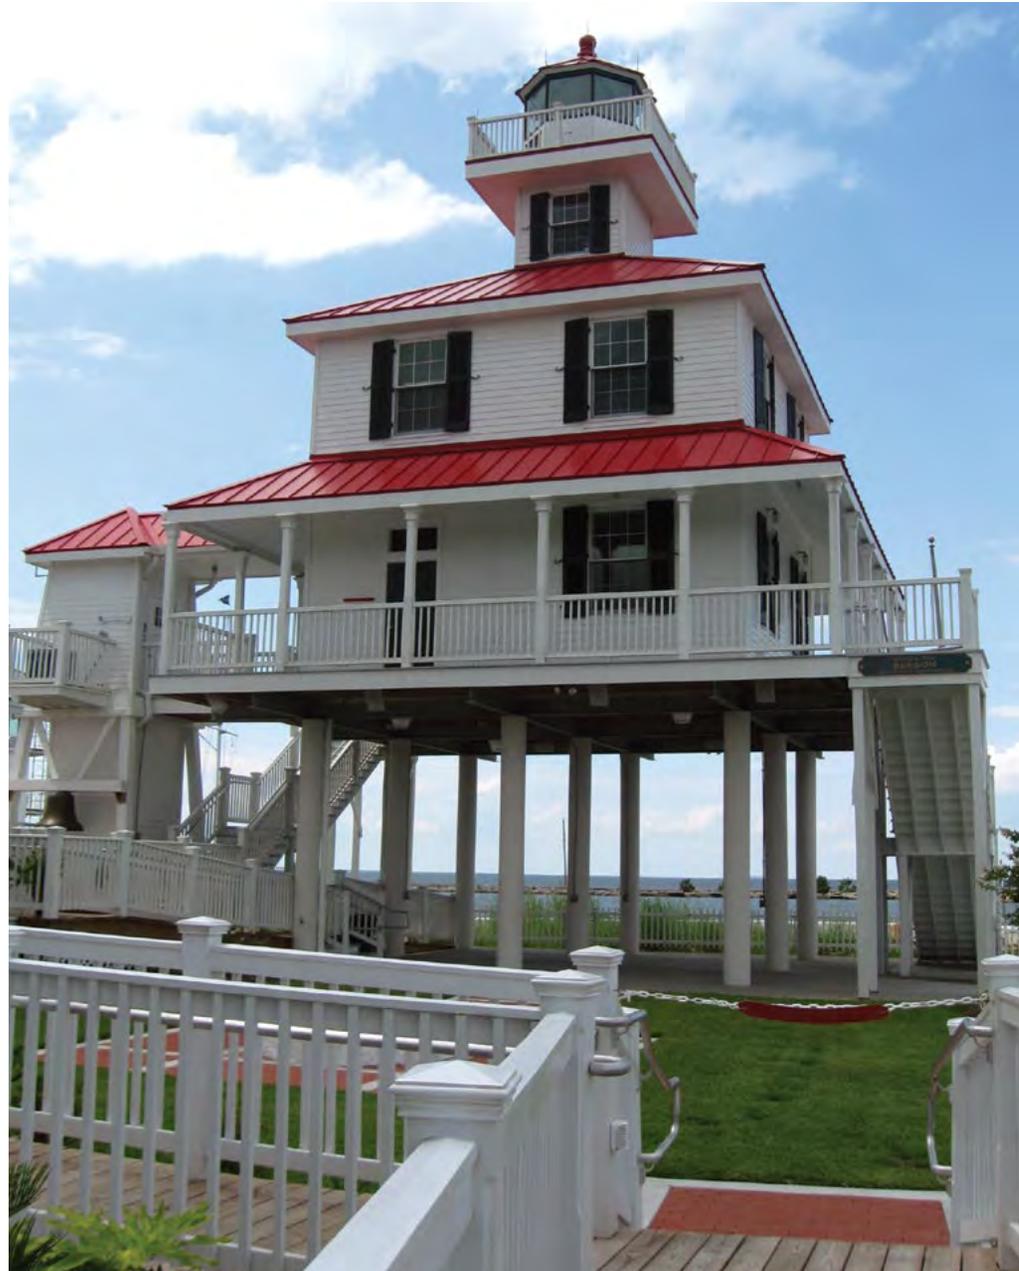
[6] This lighthouse on Lake Ponchartrain in New Orleans was reconstructed after the historic 1890 lighthouse was destroyed by Hurricane Katrina.
