City of Boulder City Historic Water Filtration Plant  
Historic Structures Final Report

February 23, 2022

# Pre-Demolition Asbestos and Lead Based Paint Survey Boulder City Historic Water Filtration Plant 300 Railroad Avenue Boulder City, Nevada

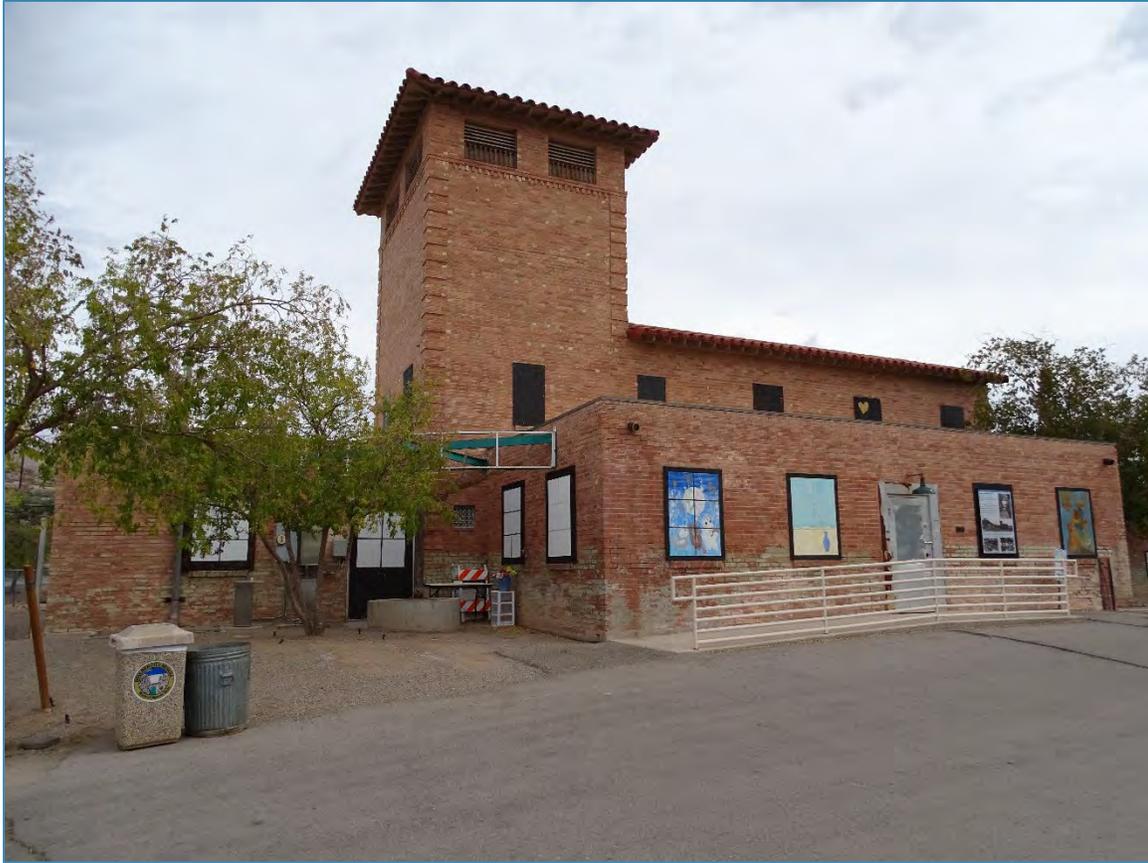
The west (main) façade consists of, from left (north) to right (south), the west façade of the northwest addition, central building and tower, the west extension, and west façade of the loading dock (Photograph 2). The west façade of the northwest addition contains an infilled window on the north end, and a single-leaf metal door with infilled window on the south end. What appears to be a capped well in the form of a raised concrete cylinder is located west of the door. A steel sculpture supporting a metal awning frame rests atop the cylinder. The metal frame consists of two crossed steel beams supporting a curved metal frame. Utility equipment is located to the north of the door. An opening with a decorative metal grill is located to the south of the door on the lower portion of the west façade of the tower. Two infilled windows face north on the west extension.

Photograph 2. North end of the west (main) façade of the Plant, facing east.

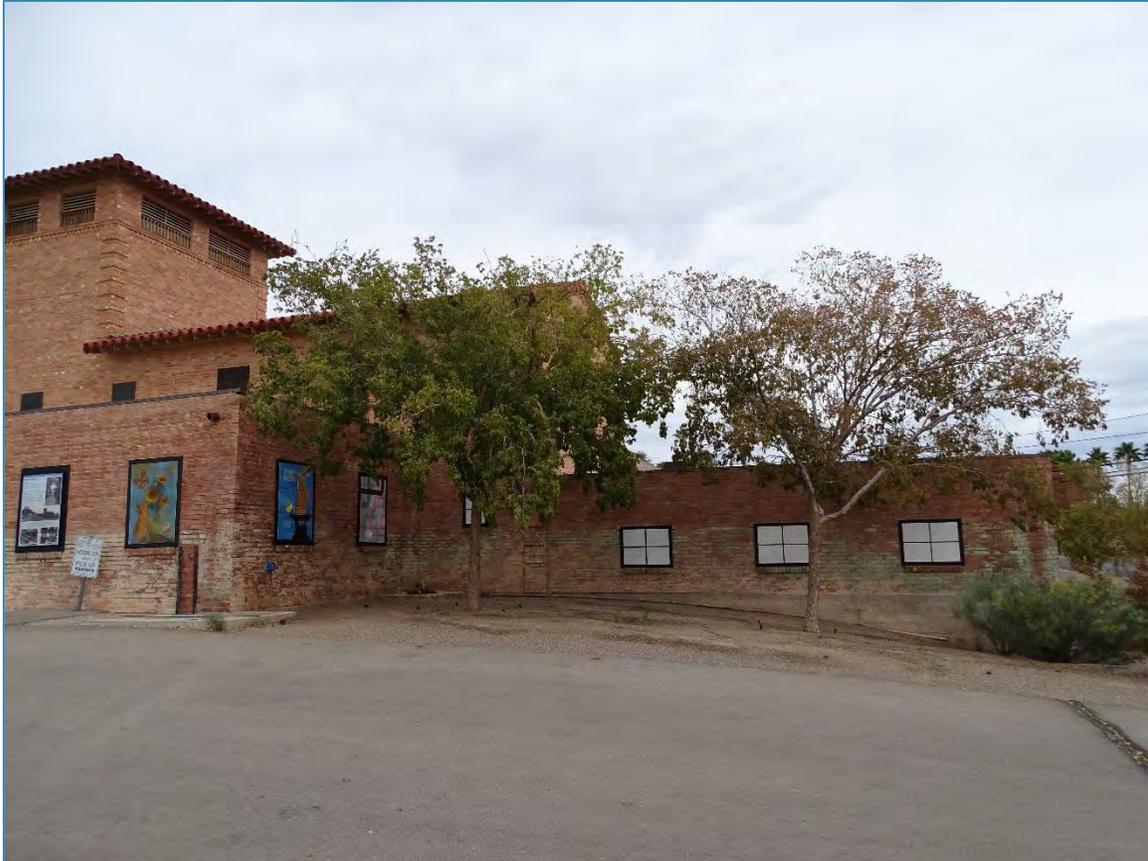
The main entry is centered on the west façade of the west extension, flanked by two in-filled windows on either side of the entry. One window is in-filled with an interpretive marker. The entry consists of a metal door with in-filled opening and a thick metal frame. The door and frame are not original to the building. The frame covers the original decorative brick surround.<sup>4</sup> A modern concrete ramp with metal pipe handrails is located in front of the west façade. Two tile roof drains are located at the north and south end of the parapet wall. A concrete pad with steel doors leading to a chamber below grade, and a water pump, are located at the south end of the west façade. The south façade of the west extension contains two in-filled windows. The west façade of the loading dock extension contains three smaller in-filled windows. The west façade of the tower includes two louvered openings at the top of the tower (all four sides of the tower are identical), and five evenly spaced in-filled windows at the second story level. The finished grade slopes southward here, revealing the loading dock's board-formed concrete base (Photograph 3).

Photograph 3. South end of the west (main) façade of the Plant, facing northeast. Note board-formed concrete at the base of the loading dock extension.

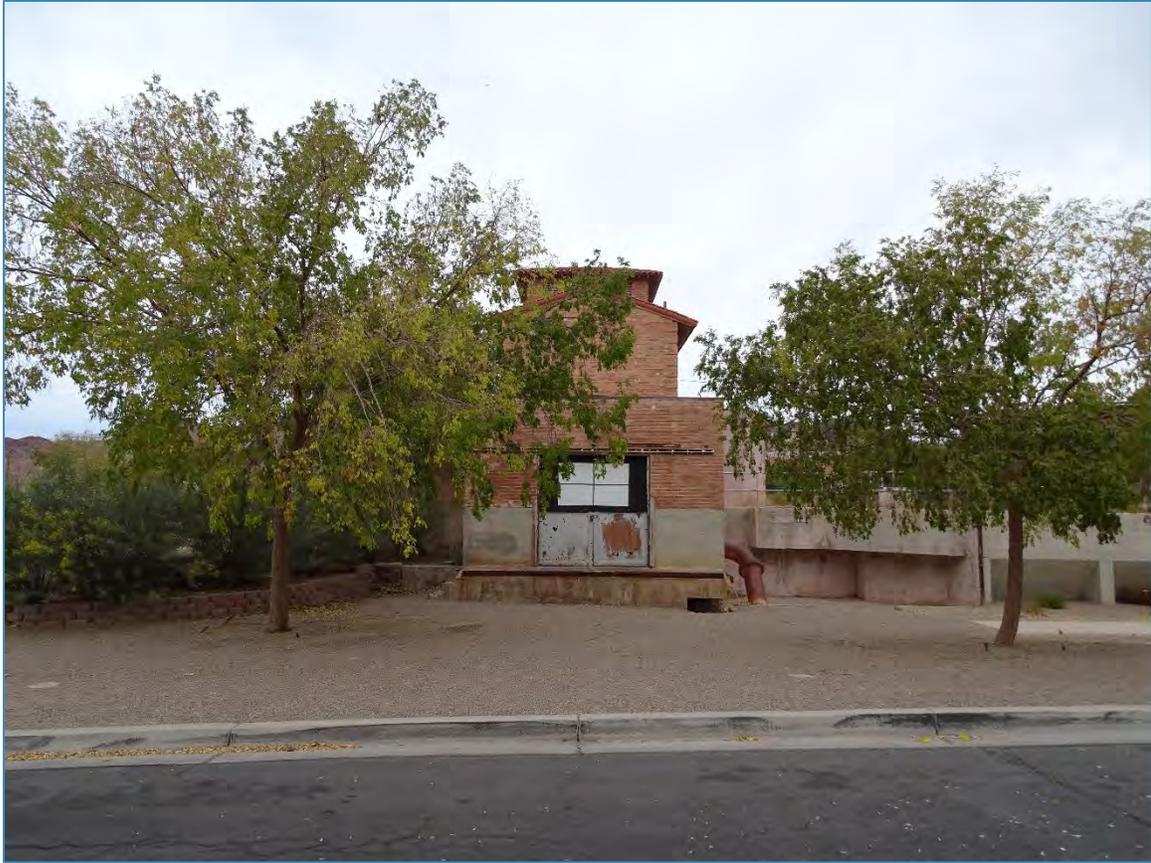
The south façade of the loading dock contains a set of double metal doors with infilled windows and steel door guards in the center of the façade (Photograph 4). A shallow concrete dock with a set of three concrete steps on the west end is located in front of the doors. The steps are trimmed with metal safety treads, and a piece of steel angle iron trims the front (south) of the dock. According to the original building drawings a matching set of concrete steps was located at the east end of the dock. It appears that they have been removed to accommodate an opening under the dock. A piece of wood is bolted to the north end of the dock. The east façade of the loading dock extension mirrors the west and contains three infilled window openings; however, the northernmost window is slightly larger. A large pipe extends from the south end of the extension and turns south at an angle before continuing below grade. The south façade of the concrete clarifying tanks extends from the east façade of the loading dock extension. A short railroad spur (no longer extant) of the U.S. Construction Railroad (U.S. Government Railroad) that delivered chemicals required for Plant operations to the Plant's loading dock was located just south of the dock along the north side of Railroad Avenue.

Photograph 4. South façade showing the loading dock (center) and west end of the clarifying tanks (left), facing northwest.

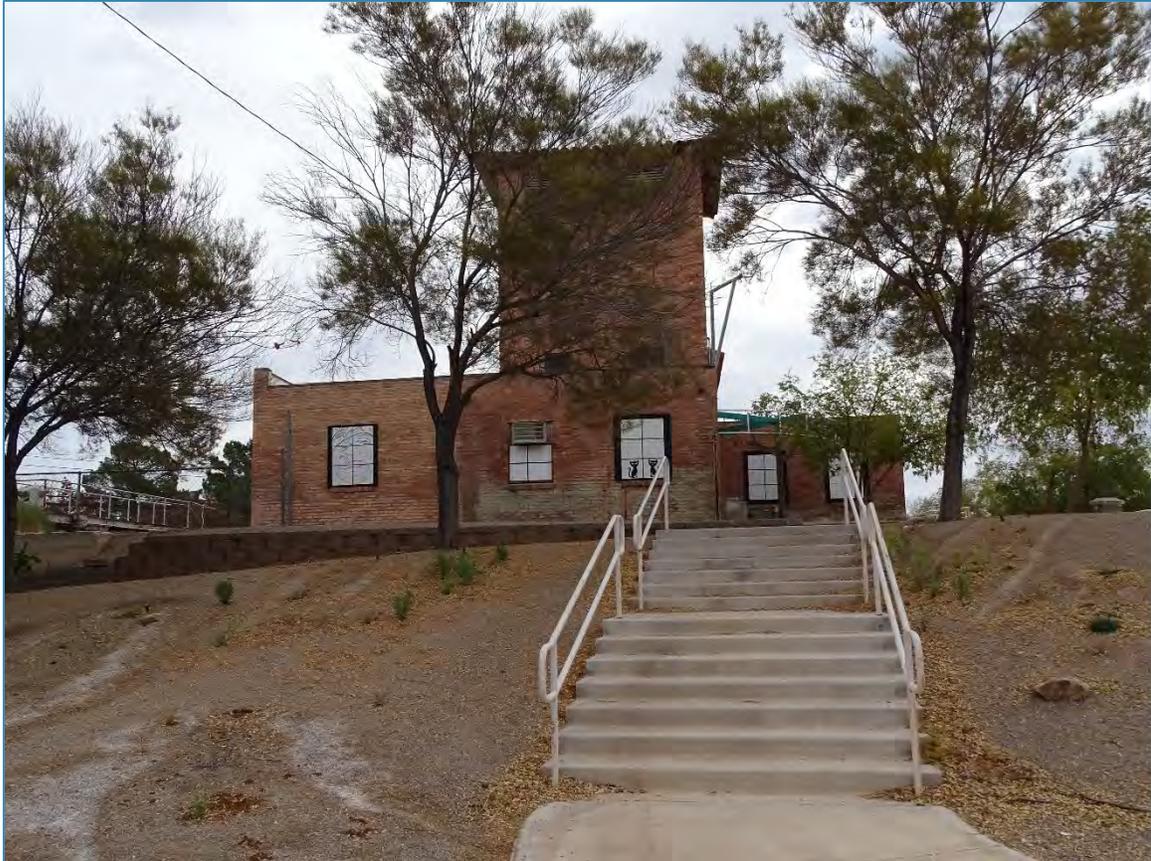
The east façade of the second floor of the central building contains five window openings, three of which are infilled. The two southernmost windows left uncovered are eight-lite steel casement style. The northernmost opening is different in that a horizontal component extends northward from the top of the window to create an upside-down L shape. The east façade of the rectangular addition contains, from left (south) to right (north), a single-leaf entry and three window openings. The notched corner at the southeast corner of the addition is constructed of wood and has a smooth finish (Department of the Interior, 1950). Two tile roof drains are located at the south and north ends of the addition's east parapet wall. The north façade of the addition contains three infilled windows. Two infilled windows face north on the tower's second story. A set of concrete steps with metal pipe handrails leads from the north parking area to a gravel area north of the building (Photograph 5).

Photograph 5. North façade of the plant showing concrete stairs leading to the north parking area.

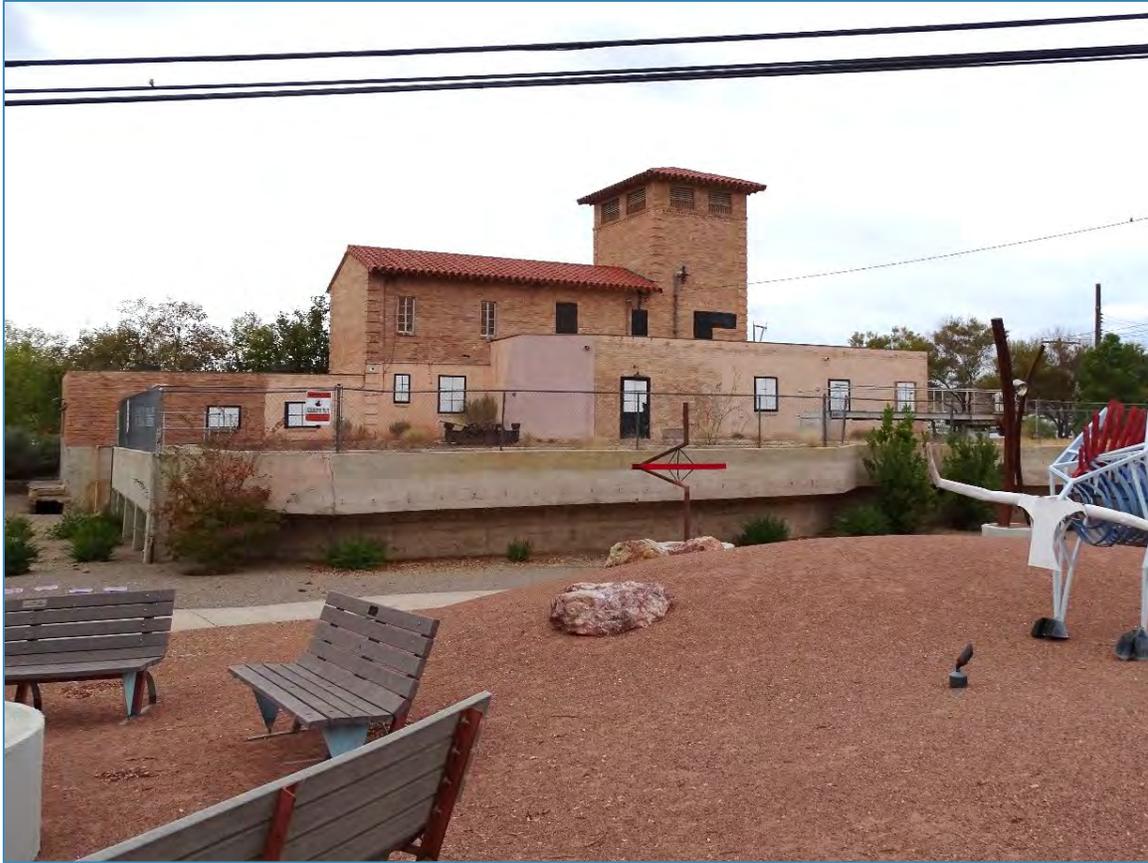
Two 45-foot diameter concrete clarifying tanks, a series of concrete recarbonizing chambers located in between the clarifying tanks, two chemical mixing tanks located west of the clarifying tanks, and associated equipment are located to the east of the building. The above-ground board-formed concrete linings of the clarifying tanks, the top surfaces of the chemical mixing tanks and the concrete recarbonizing chambers, and above-tank equipment are extant; however, the tanks and chambers have been infilled with dirt. Additionally, two chemical mixing tanks were removed as part of the 1950 addition. Metal pipe handrails and chain link fencing line the tanks (Photograph 6).

Photograph 6. East façade of the Plant, facing west. The clarifying tanks are the large, raised concrete structures in the foreground.

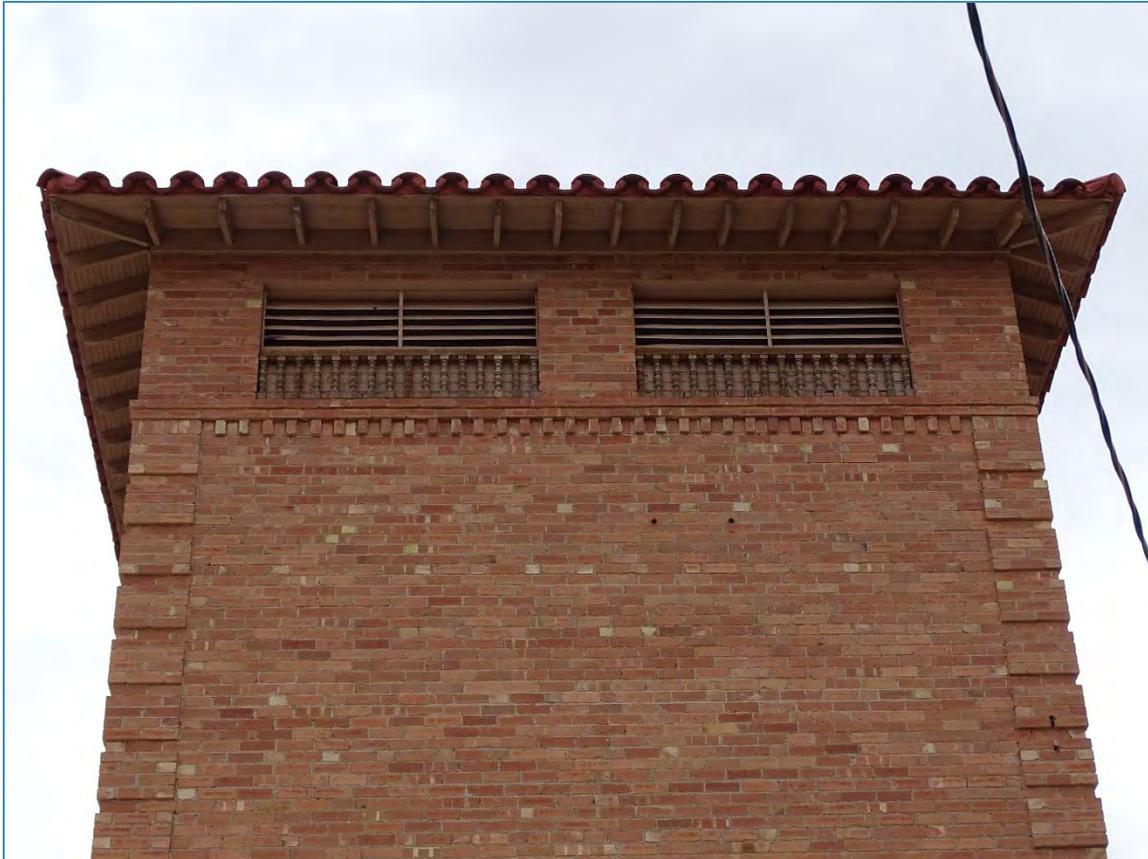
Photograph 8. Copper louvered vents with turned wood balustrades on all four sides of the tower, and brick quoins, are significant features of the Plant.

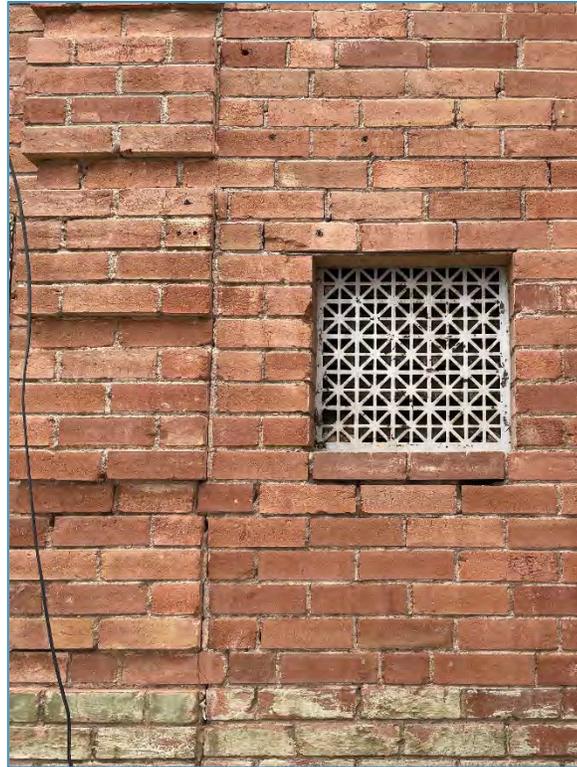
Photograph 9. Decorative grate at opening and brick quoins at west façade.

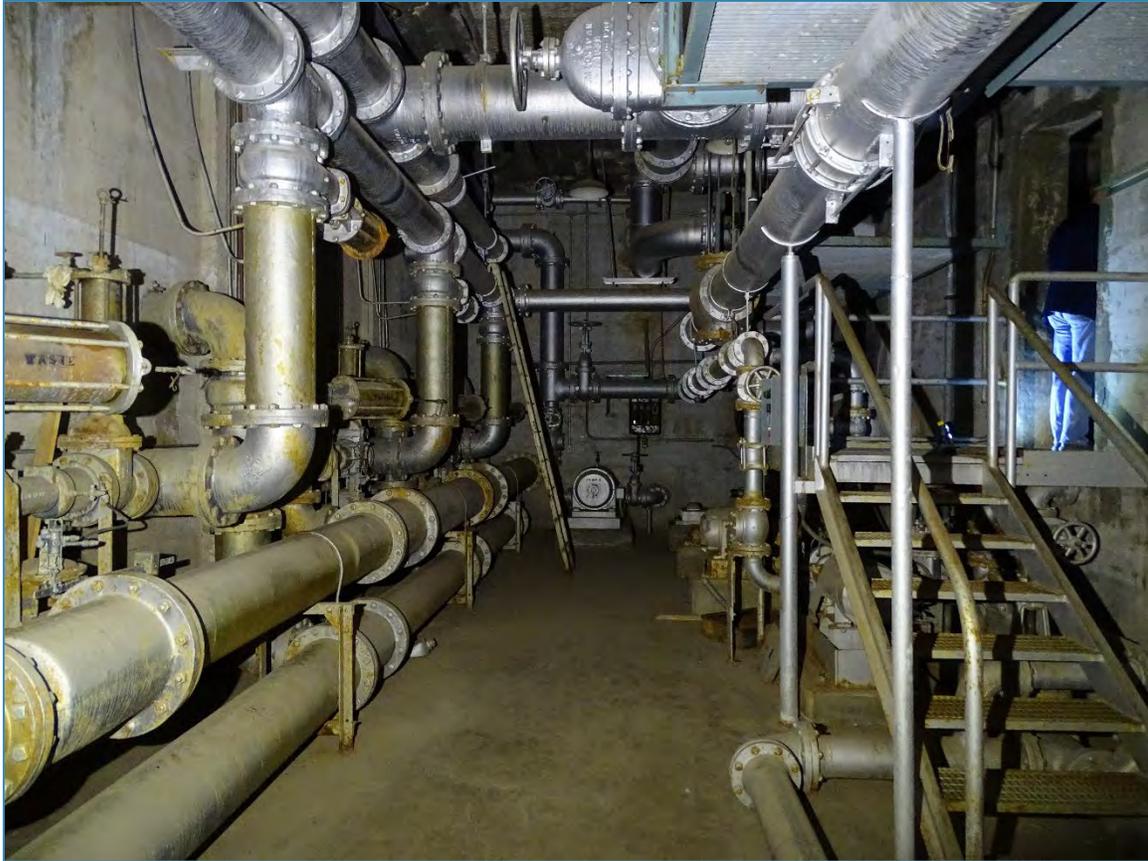
Photograph 10. The pumping equipment, pipes, and conduit in the basement pipe gallery are considered significant interior features.

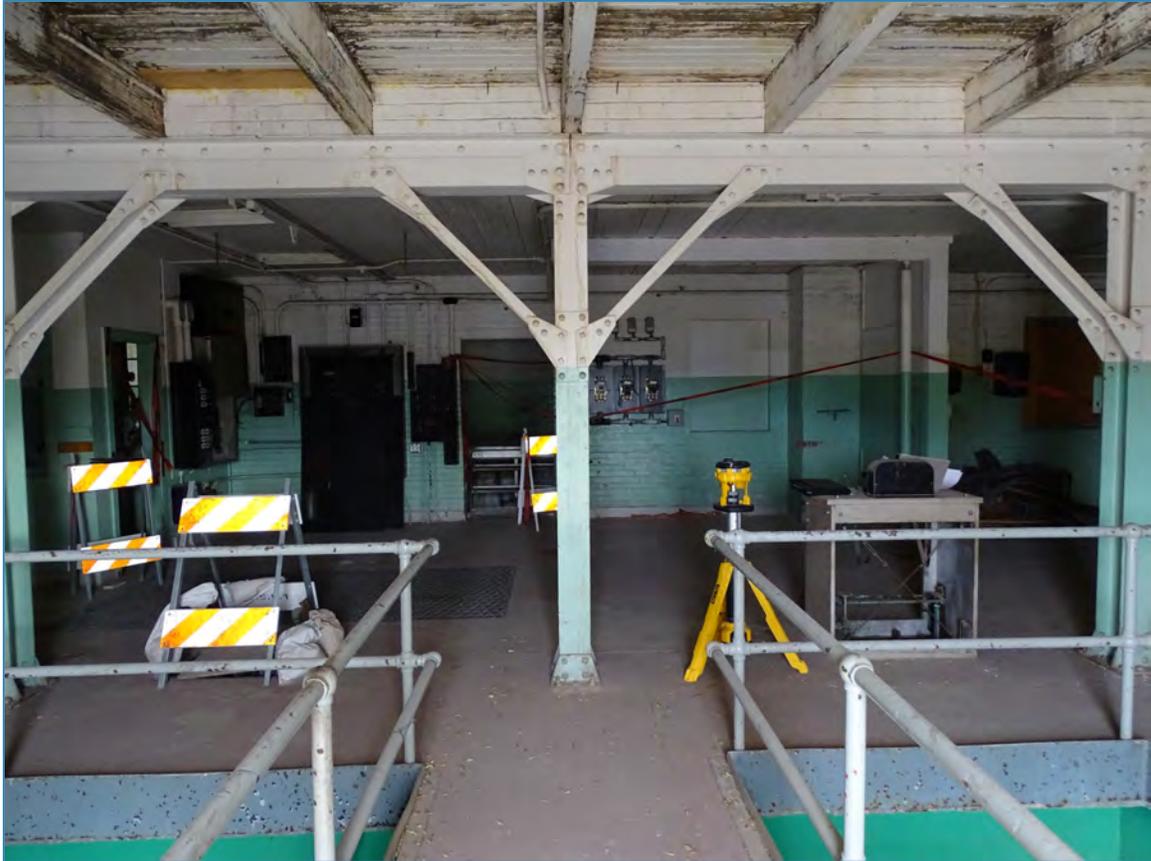
Photograph 11. Interior of Operating Floor showing structural steel beams and columns with rivets, facing northeast. The columns and beams are considered character-defining features.

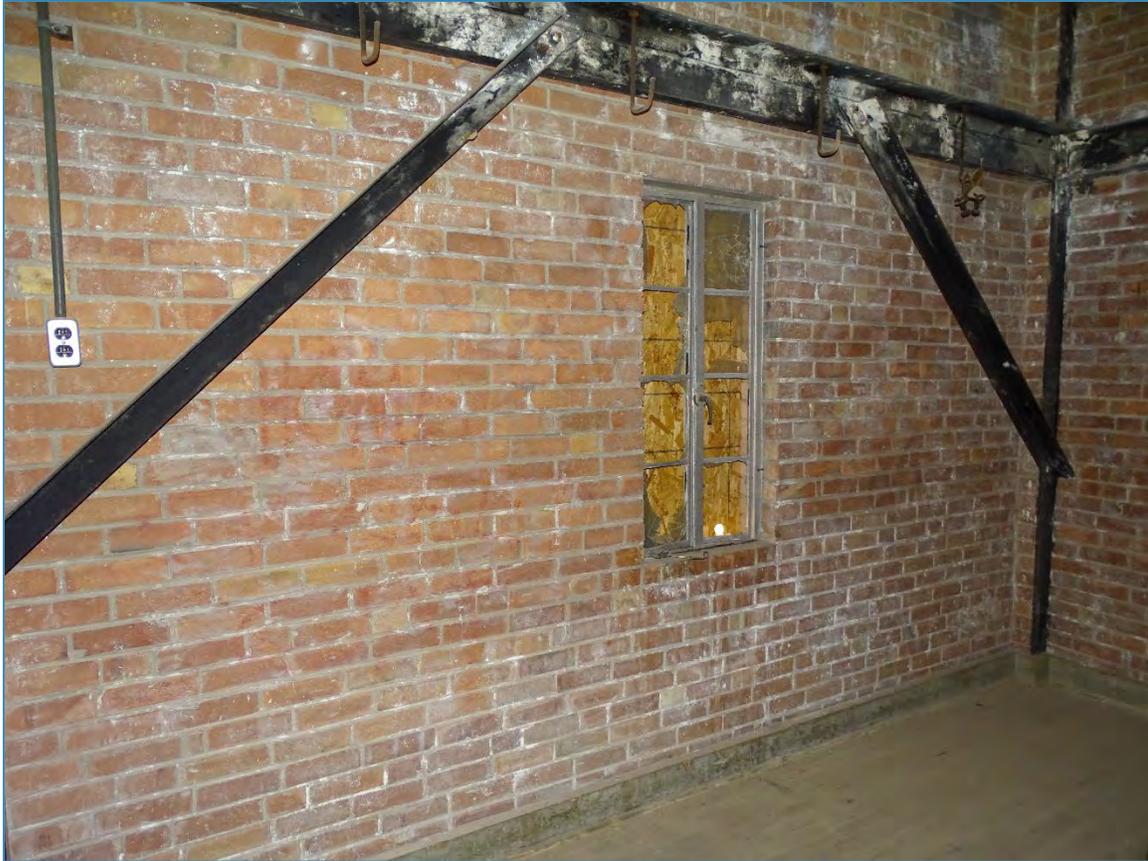
Photograph 12. Exposed brick in the tower. Exposed and painted brick surfaces are considered significant interior features.

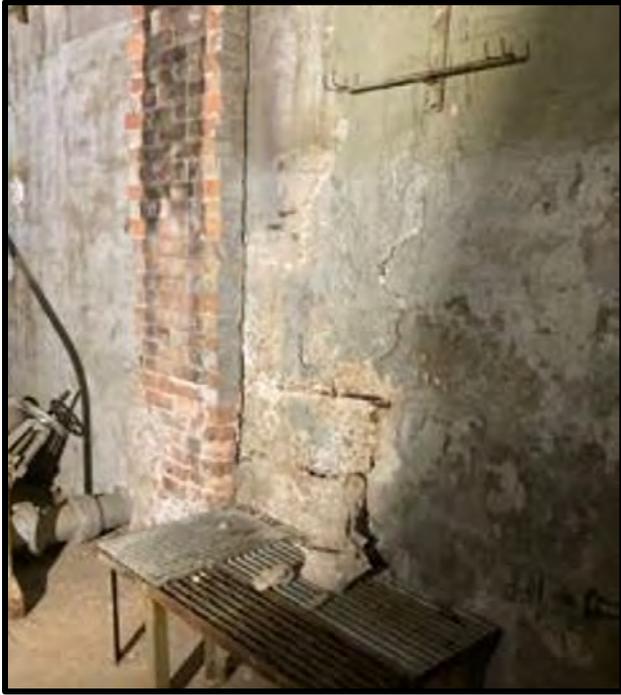
Figure 12 – Concrete Spalling and Deterioration at Pipe Gallery Foundation Wall

to good condition where exposed to view. At the Pipe Gallery there were isolated areas where the concrete walls have begun to spall and expose the rusted reinforcing bars (see Figure 12).

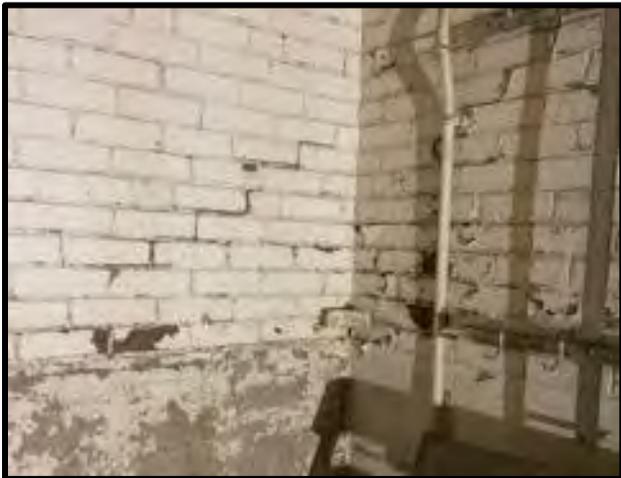
Figure 13 – Step Cracking at South Corner of Unloading Shed

There is limited evidence of differential settlement at the site except for the Unloading Shed. Some vertical and diagonal cracking was noted in both the concrete stem walls and the brick masonry walls above. The foundations for this portion of the building are not on mat and are at a higher elevation than the rest of the structure, which may partially explain some of this observed distress (see Figure 13).

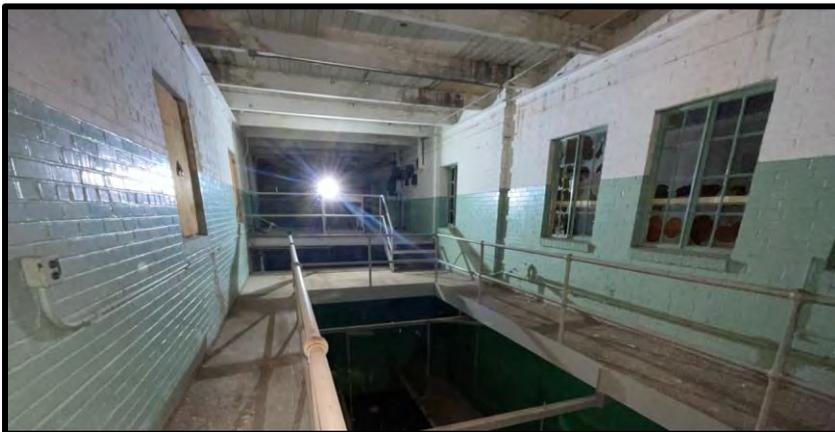
Figure 22 – Good Condition of Floors at Northeast Addition

The floor framing is generally in fair to good condition where observations could be made. In particular, the wood and steel floor framing appear to be in good condition relative to their age, with few signs of deterioration outside of some surface corrosion on the steel and water staining on the wood (see Figure 22).

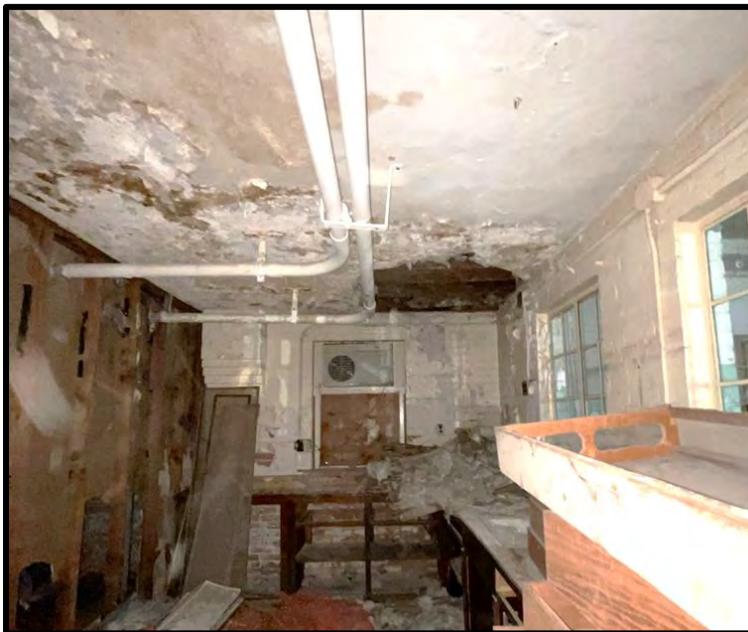
Figure 27 – Plaster Ceiling Failure at NW Addition

The wood roof framing is in fair condition. At the original 1931 construction there has been some moisture infiltration over time, but it appears to have caused limited structural damage. Some water staining is evident at rafter and sheathing, and the paint is failing, but it does not appear to have caused any significant section loss of the wood. At the two flat roofs added over the addition more significant water damage is evident. There are signs of significant water damage at the Northwest Addition. A ceiling is in place, so observations were limited, but the interior finishes had started to fail in response to the moisture and it is very likely there is damage to the underlying roof rafters (see Figure 27).

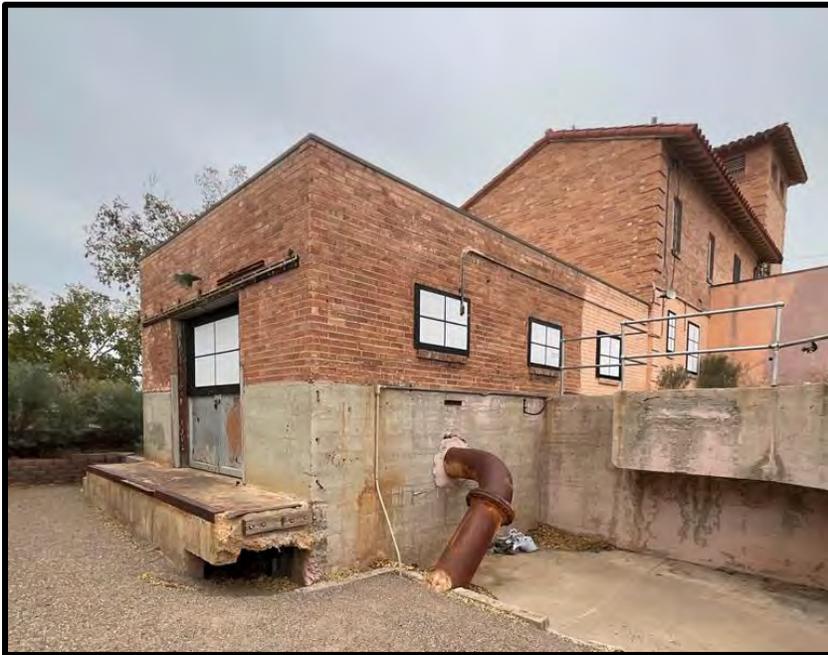
Figure 28 – Photo at South End of Site Showing Loading Dock (left) and Clarifier Tanks (right)

At the south end of the Unloading Shed there is an exterior concrete framed stair/loading dock that has been partially demolished. At the east end of the site several feet of the concrete walls around the Clarifier Tanks are still visible (see Figure 28).

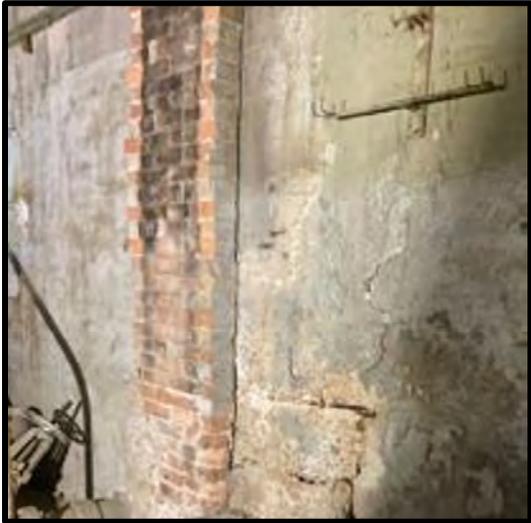
Figure 32 – One Wythe of Old Chimney Still Remains

There is a chimney that was within the two story portion of the Operating Floor, which was demolished at some point in the past. Portions of this chimney remain at the basement level and pose a falling hazard with questionable stability (see Figure 32).

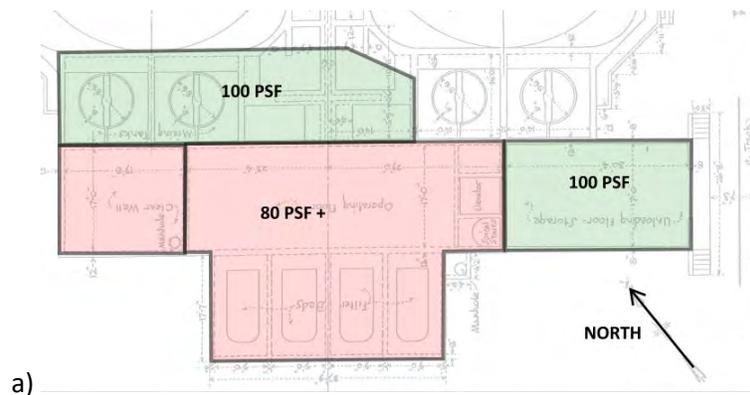
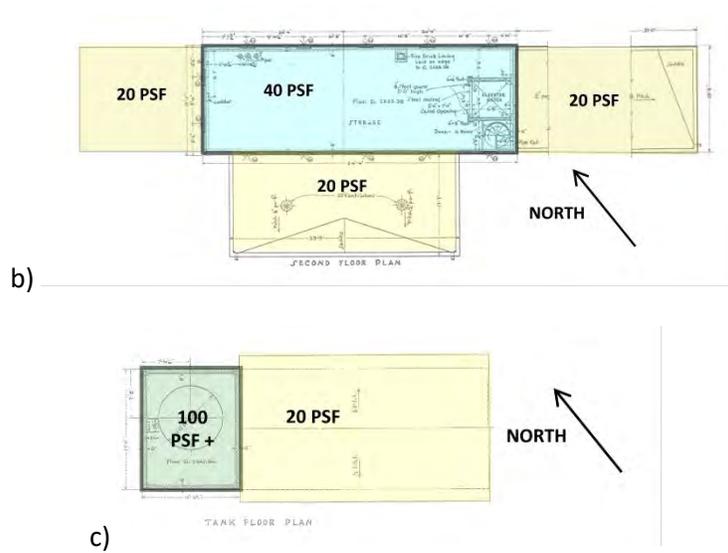
Figure 34 – Schematic plan showing preliminary capacities of a) ground floor, b) second floor, and c) tank floor level

Based on the limited information found in existing drawings, the first-floor member capacity may be between 80 and 100 pounds per square foot (see Figure 34). Additional probes are required to confirm the design assumptions used in the strength calculations as this capacity is based on select members where information could be gathered in the field or from provided documentation – many structural elements within the floor assembly have not yet been evaluated due to lack of information.

The spacing of the second-floor wood joists is currently unknown. Preliminary assumptions are that the joist spacing may be between 12 to 24 inches. At a 12-inch spacing the member exhibited a deflection deficiency at 40 psf. Additional probes to identify wood species and joist spacing will help confirm the capacity.

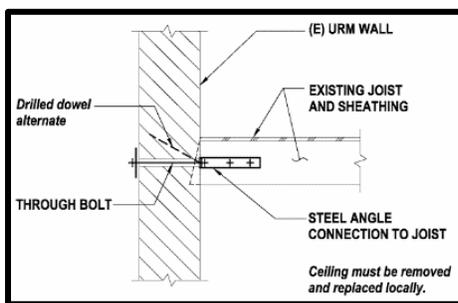
Figure 37 – Conceptual retrofit detail to supplement out of plane anchorage capacity

The current out of plane detailing is not adequate for an improved seismic performance. Improved seismic detailing of the out of plane masonry attachments can supplement the capacity of the existing anchors. New tension anchors can be added to the floor level as shown conceptually in Figure 37.

- Seismic Repairs – Based on the preliminary assessment additional anchorage of floor and roof diaphragms to masonry walls will be required. In addition, it is recommended that a plywood overlay be installed over existing wood sheathed floors/roofs to strengthen the diaphragms for seismic. Finally, some localized reinforcement should be anticipated at one or two wall lines to address shear issues. The reinforcement could take several forms – FRP added to the inside face, shotcrete, or at the tower potentially adding in new bracing to the existing steel frame that is already integral with the wall.

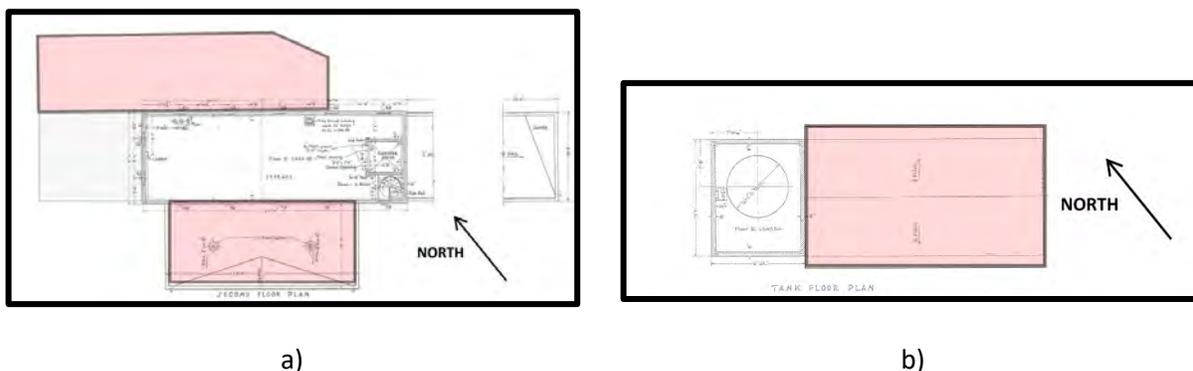
Figure 38 - Schematic plan showing diaphragms with a vulnerable aspect ratio a) storage floor, and b) tank floor levels

Straight-sheathed diaphragms have less lateral capacity as compared with plywood or even diagonally sheathed diaphragms. The ASCE 41-17 Tier 1 checklist identifies any diaphragm with a length-to-width ratio greater than 2-to-1 as a potential vulnerability. Further evaluation is necessary, but it appears a plywood overlay may be required at some of the wood framed floors and roofs.

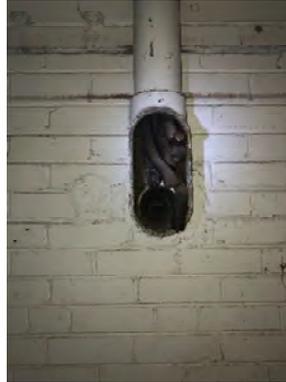
The original electrical service entrance was located on the Northeast side of the property stubbed to a weather head approximately 20' high on the water tank tower. The service has been disconnected and removed to the weather head with cables inside the building being cut at the nearest accessible point in the building. Refer to Photo 1 & 2 for disconnected service locations.

Photo 1 - Interior Service Entrance Conduit and Cut Conductors

A new electrical service will be required, size to be determined based on new building use. The existing service location can be reused however new conduit, conductors, weather proofing, and weather heads will need to be installed.

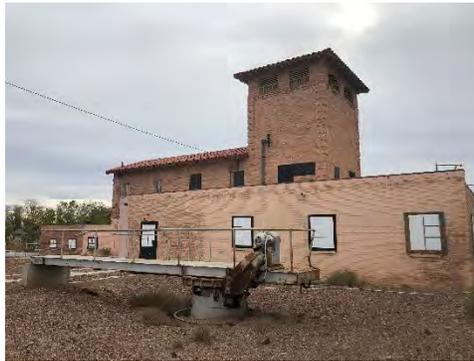
Photo 2 - Exterior Service Entrance Weather Head, looking South

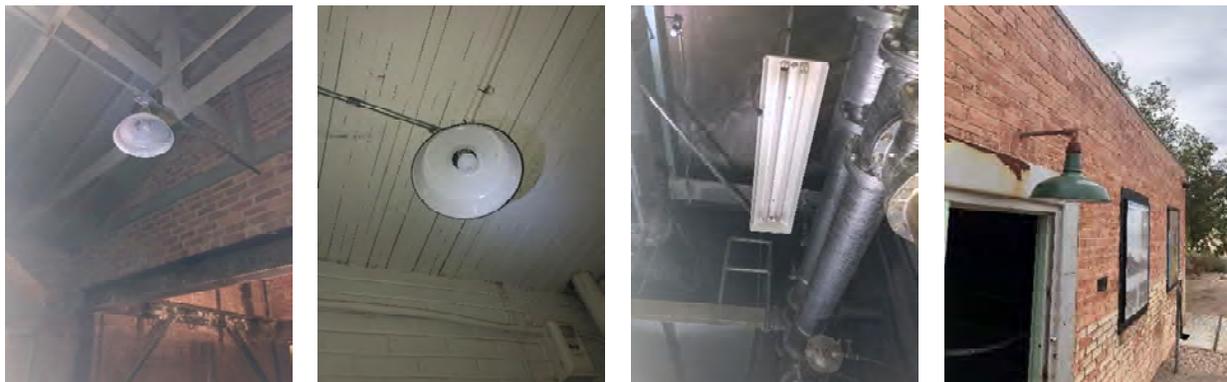
Existing lighting is a combination of fluorescent T12 tubing, and incandescent light bulbs in pendant fixtures. Exterior façade light fixtures are similar in appearance to the interior pendant mounted fixtures, except wall mounted. Refer to Photo 3 for typical fixtures. The fixture housing can remain or be replaced with a new fixture matching the original form-factor. No additional exterior lighting was found on the property for the adjacent community gardens or the parking area. Additional fixtures are recommended to comply with IES recommended light levels. New LED light sources will need to be installed throughout to comply with IEC recommended lighting levels, egress lighting, and energy consumption compliance.

Photo 3 - Typical Existing Light Fixtures

Egress lighting and exit signage will need to be installed throughout. Recommend providing battery back-up on board new fixtures and exit signs in case of normal power loss.

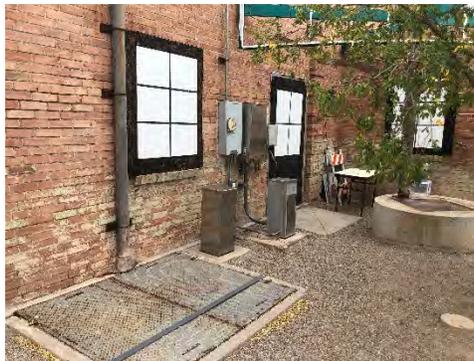
Existing telephone and data systems service entrance is at grade on the Northwest corner of the property, refer to Photo 4. There are exterior rated enclosures and a metering pedestal however it appears that the service is disconnected at this time. Inside of the building the existing telephone backboard board and all equipment will need to be replaced to be compatible with modern tele-data infrastructure. This is not recommended to be in view of the public as it will not be able to match the historic aesthetic of the space.

Photo 4 - Telephone Service Entrance

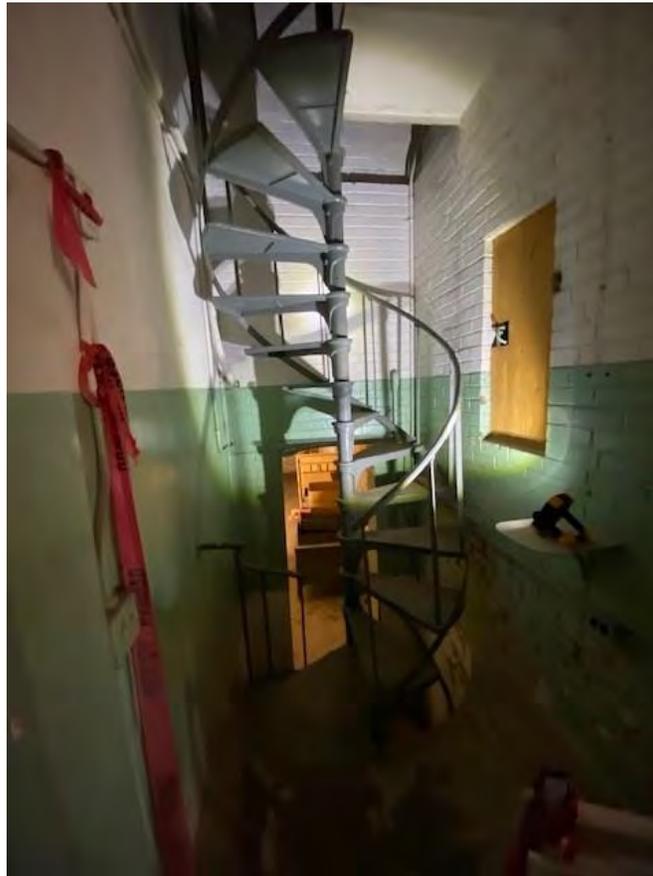
- Single spiral stairway serves Basement through Second Level
- Third Level accessible by ladder only
- Multiple elevation changes without accessible ingress/egress
- Grated floors
- Stairs without solid risers
- No exit signage
- No emergency lighting
- Elevator not functional.

**Figure 1:** *Spiral Stairway*

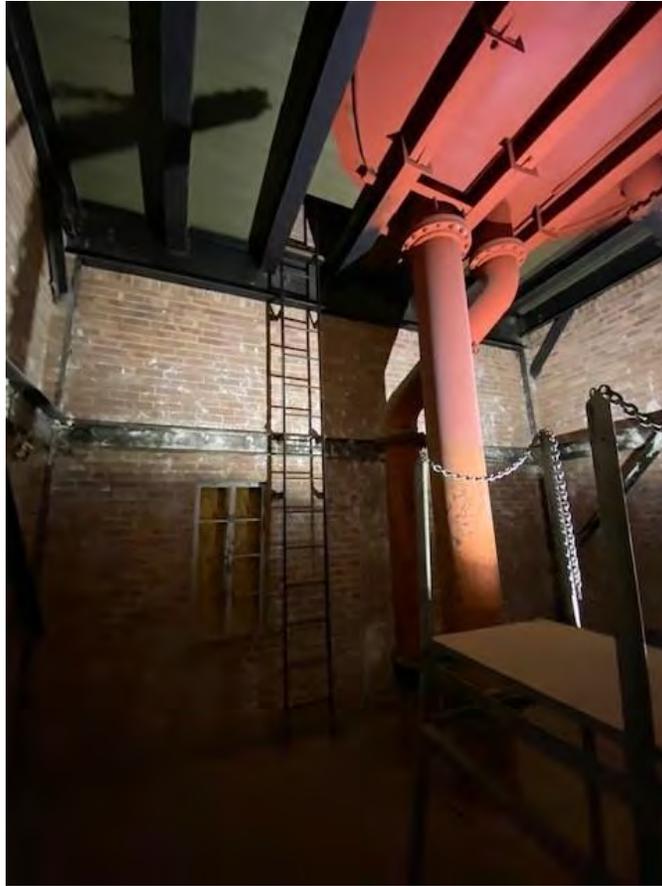
**Figure 2:** *Ladder access to Level 3 tank*

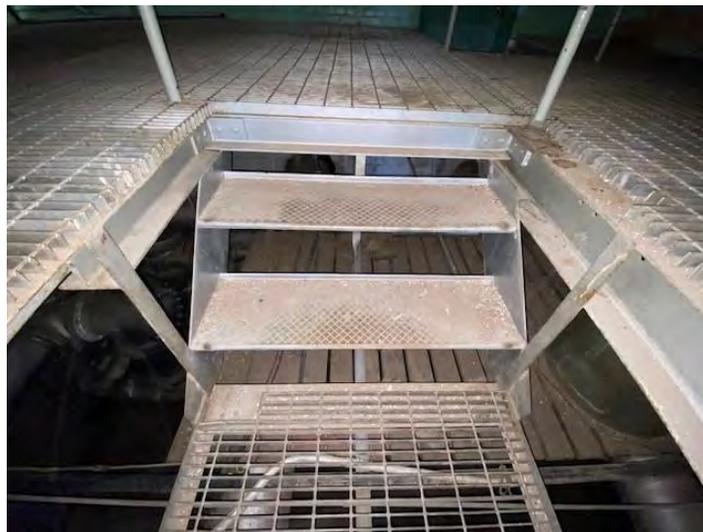
**Figure 3:** *Open grate floor and stairs*
